Annual Inspection

Mid Suffolk District Council

Beyton

The Green, Suffolk, IP30 9AF

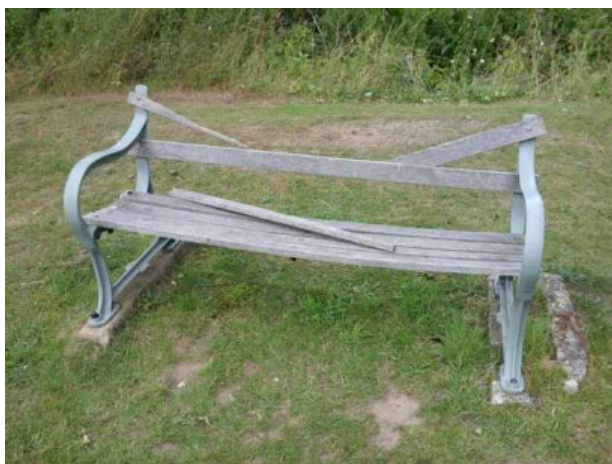
A timber rail is damaged - Replace the damaged rail

There are areas or parts of the timber on the structure that have rotted - Replace all affected timbers

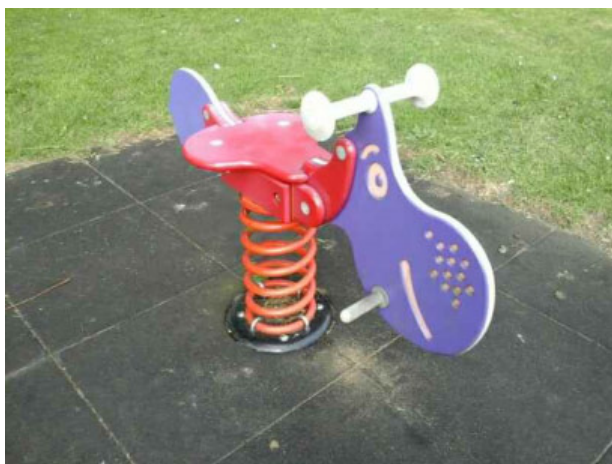
The end of handgrips and/or footrests have a cross section of less than 15cm² and fail to meet the requirements of BS EN 1176:2008 Part 6 - This is a relatively low risk failure and no remedial action is recommended

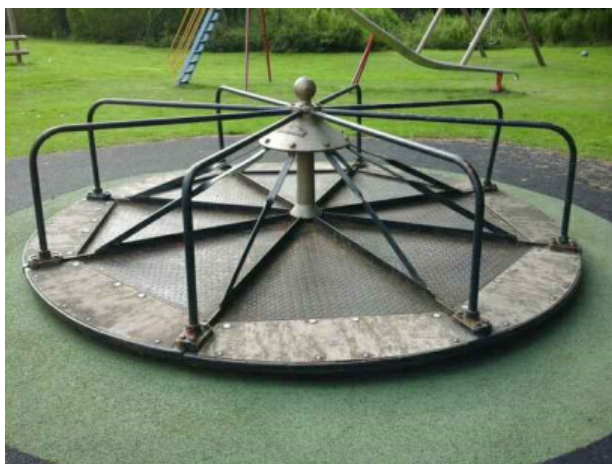
The bearing is worn - Replace the bearing as required

There is/are finger entrapment/s in the roundabout frame and the item fails to meet the requirements of BS EN 1176:2008 Part 1 4.2.7.6 Entrapment of fingers - Monitor use

The distance between the underside of the roundabout platform and the playing surface is less than 60mm and contravenes the requirements of BS EN 1176 Part 5 which requires that the distance be maintained between 60mm-110mm for the entire circumference of the roundabout - Monitor Use

The weld(s) on a handgrip has failed - Repair item

The weld(s) on a platform section have failed - Repair item

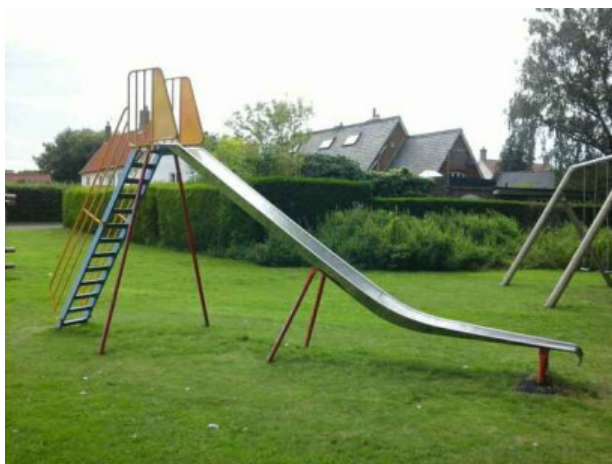
The item fails to meet the requirements of BS EN 1176:2008 Part 1 4.2.7.2 head and neck entrapment in the barriers and/or steps - Monitor use

There is some graffiti present - Remove the graffiti

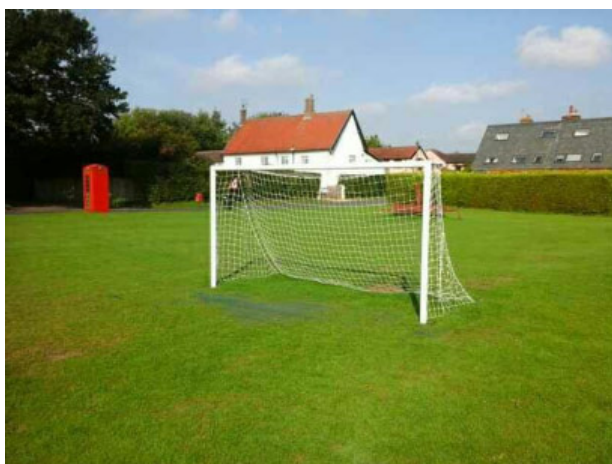
The surface has eroded in front of the goals - Reinstate the surface

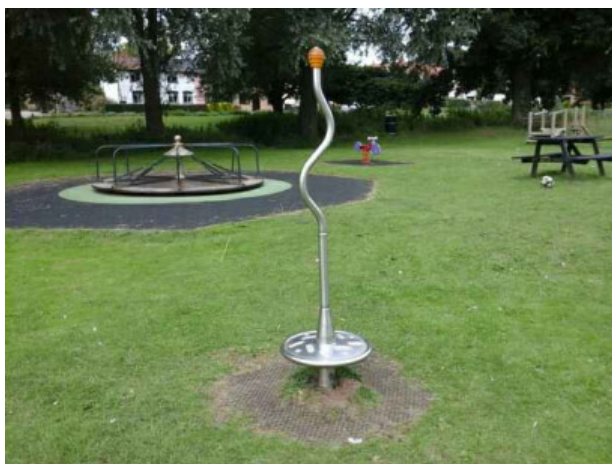
The grass mats are silted up, the soil is compacted and the area will become very slippery when the soil is wet. - Lift and relay the mats

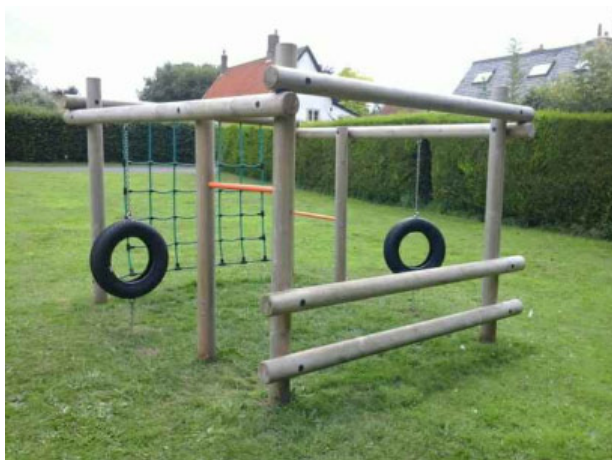
There is some strimmer damage apparent on the posts, this can penetrate the preservative applied to the timber and accelerate the rotting process - Monitor for any deterioration (rot) and replace as required

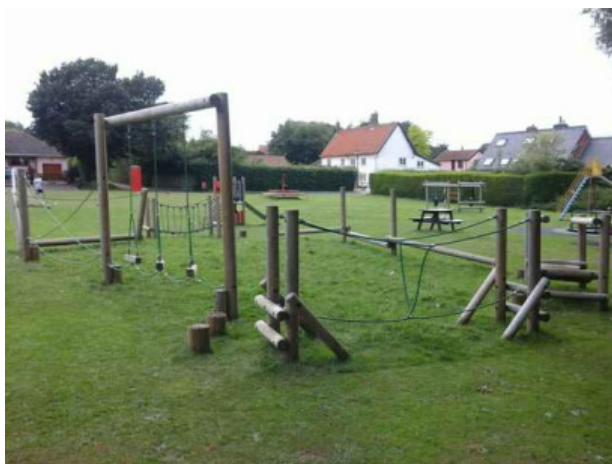
There is some strimmer damage apparent on the posts, this can penetrate the preservative applied to the timber and accelerate the rotting process - Monitor for any deterioration (rot) and replace as required

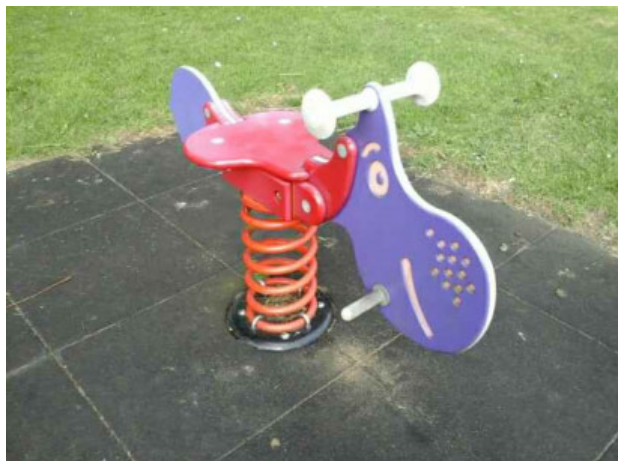
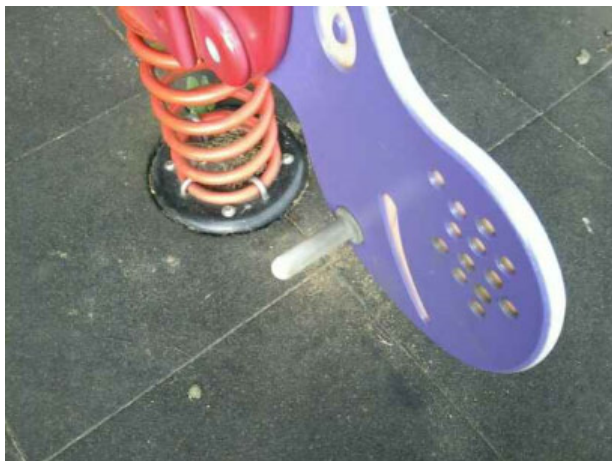
Finding: The end of handgrips and/or footrests have a cross section of less than 15cm² and fail to meet the requirements of BS EN 1176:2008 Part 6

Action: This is a relatively low risk failure and no remedial action is recommended

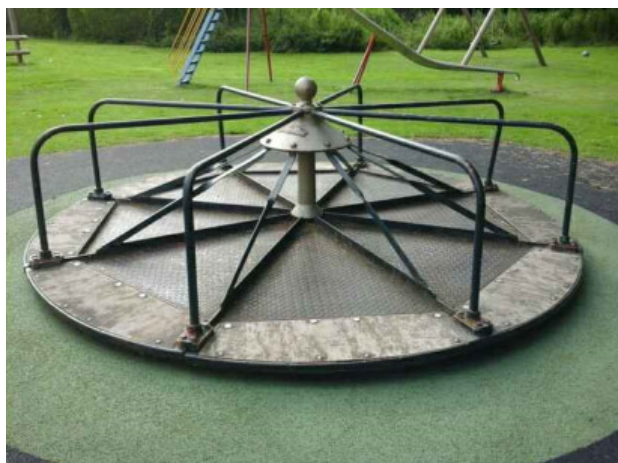
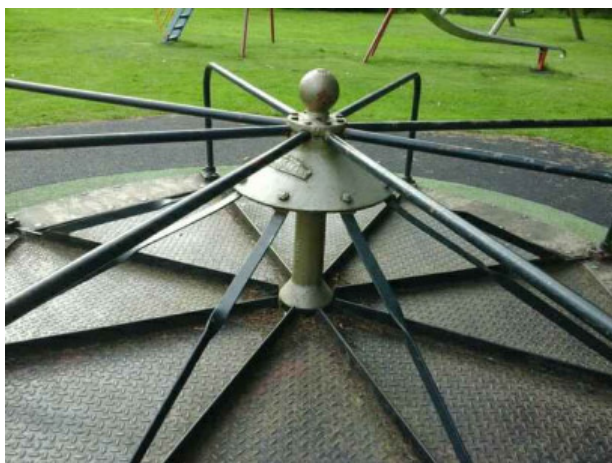
Finding: The bearing is worn

Action: Replace the bearing as required

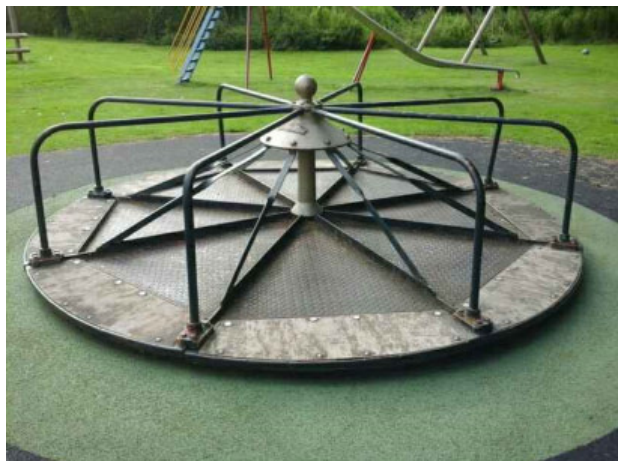
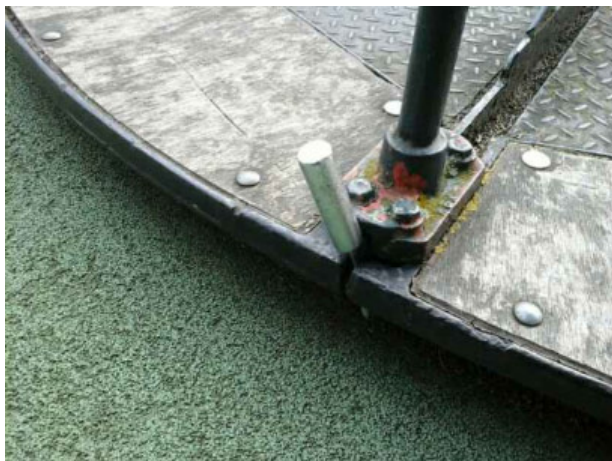
Finding: There is/are finger entrapment/s in the roundabout frame and the item fails to meet the requirements of BS EN 1176:2008 Part 1 4.2.7.6 Entrapment of fingers

Action: Monitor use

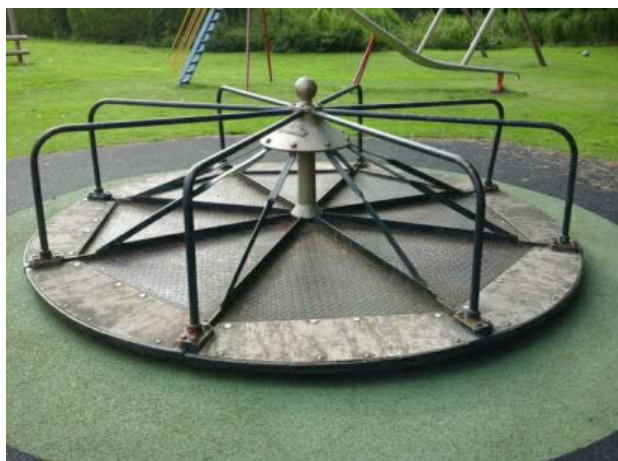
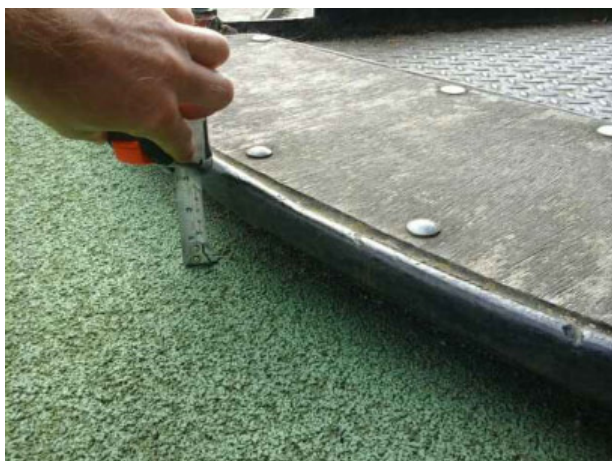
Finding: The distance between the underside of the roundabout platform and the playing surface is less than 60mm and contravenes the requirements of BS EN 1176 Part 5 which requires that the distance be maintained between 60mm-110mm for the entire circumference of the roundabout

Action: Monitor Use

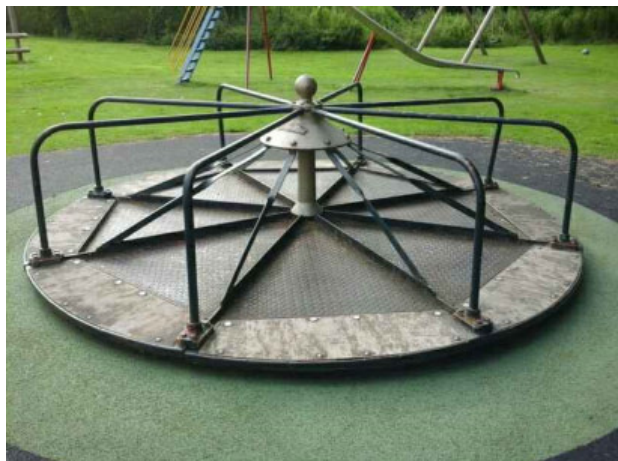
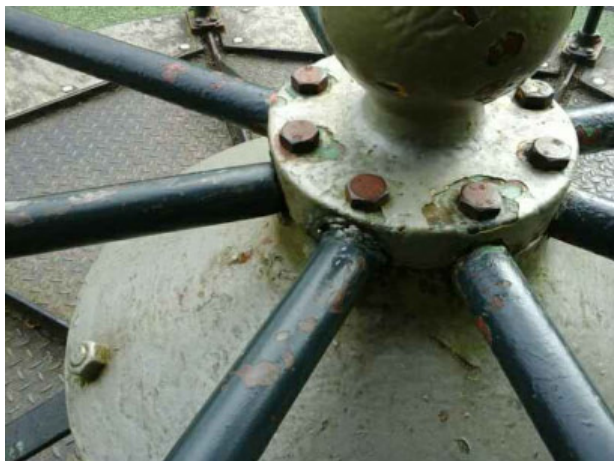
Finding: The weld(s) on a handgrip has failed

Action: Repair item

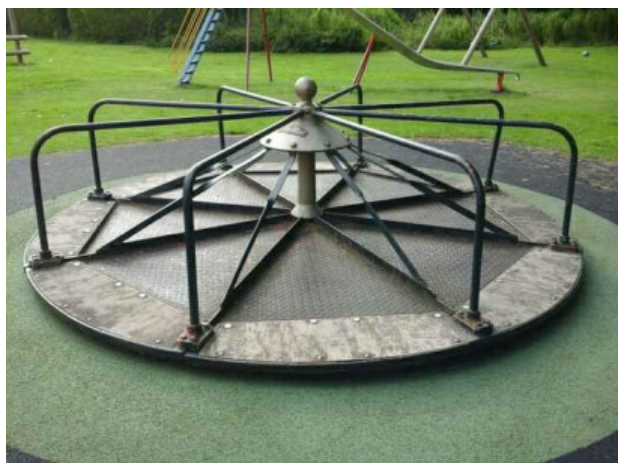
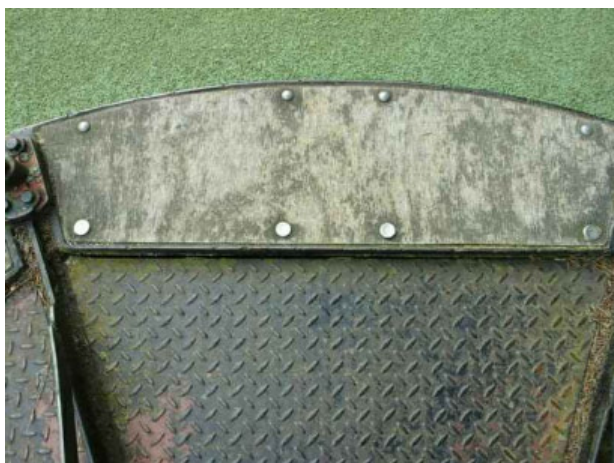
Finding: The weld(s) on a platform section have failed

Action: Repair item

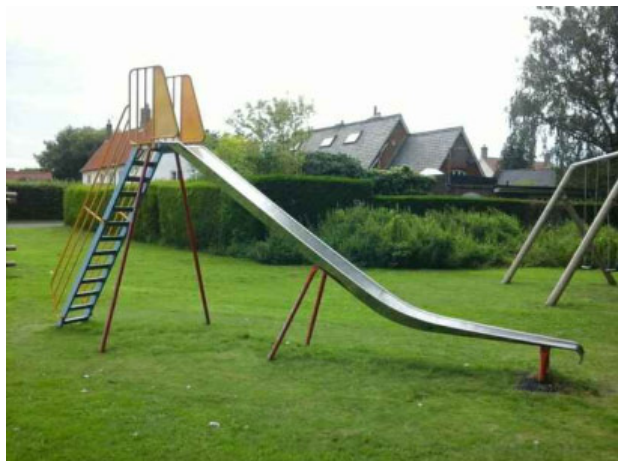
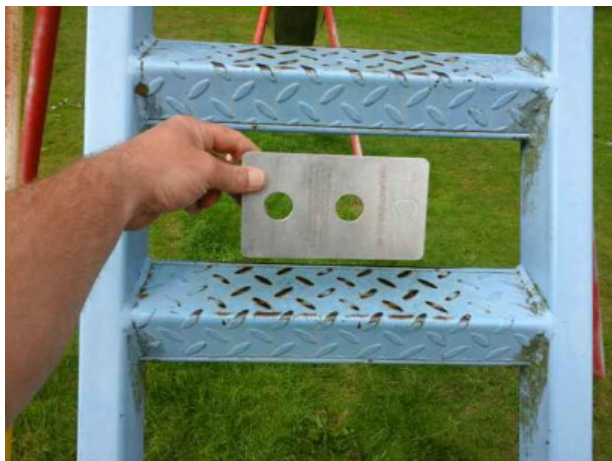
Finding: The item fails to meet the requirements of BS EN 1176:2008 Part 1 4.2.7.2 head and neck entrapment in the barriers and/or steps

Action: Monitor use

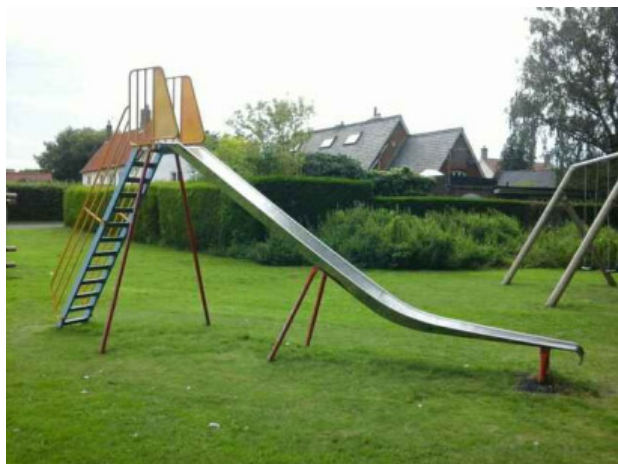
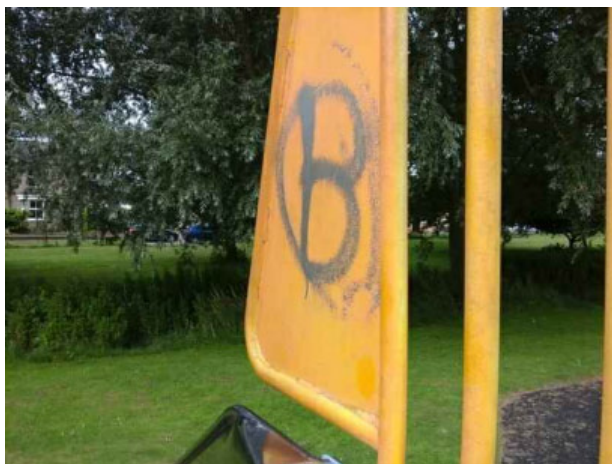
Finding: There is some graffiti present

Action: Remove the graffiti

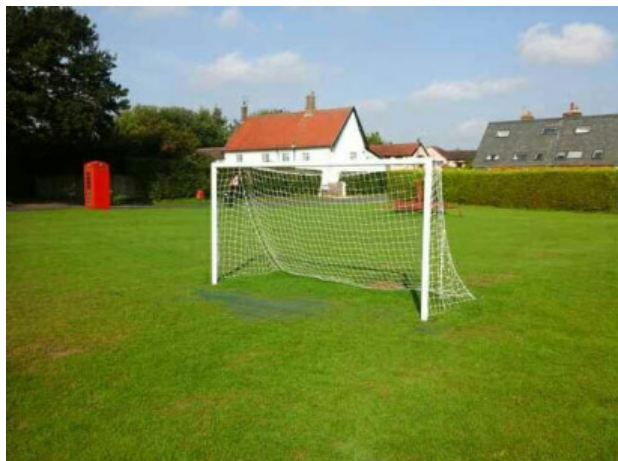
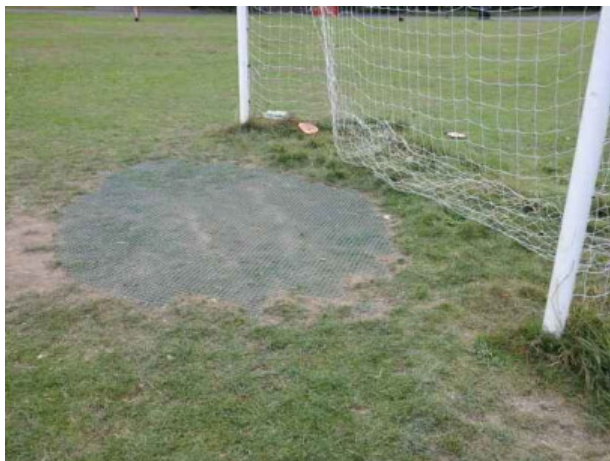
Finding: The surface has eroded in front of the goals **Action:** Reinstate the surface

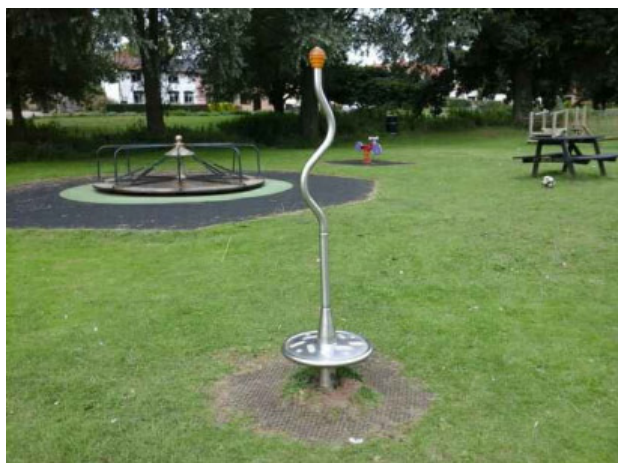
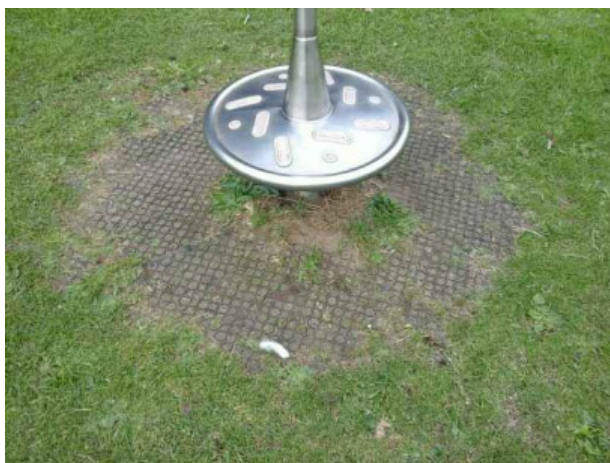
Finding: The grass mats are silted up, the soil is compacted and the area will become very slippery when the soil is wet. **Action:** Lift and relay the mats

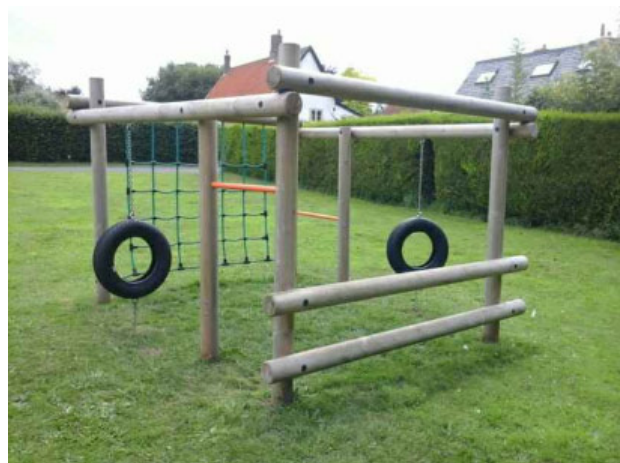
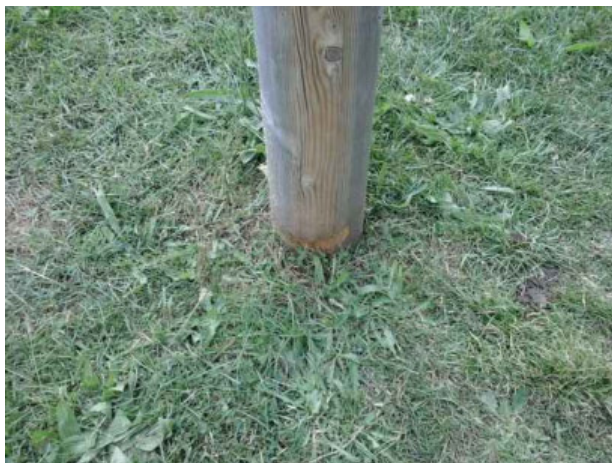
Finding: There is some strimmer damage apparent on the posts, this can penetrate the preservative applied to the timber and accelerate the rotting process

Action: Monitor for any deterioration (rot) and replace as required

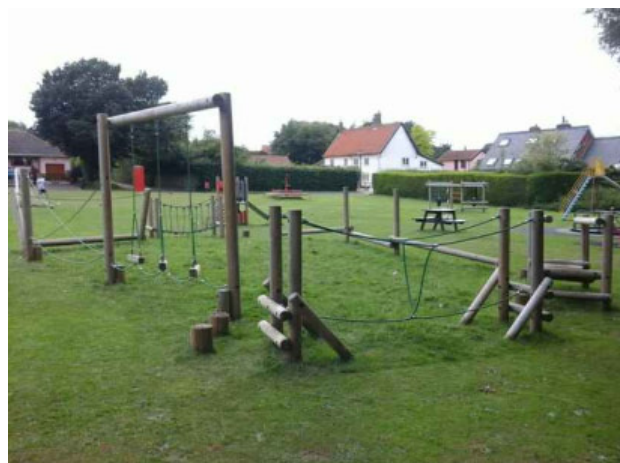
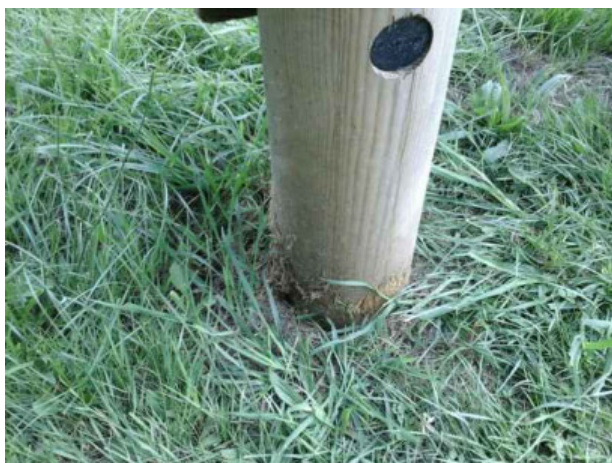
Finding: There is some strimmer damage apparent on the posts, this can penetrate the preservative applied to the timber and accelerate the rotting process

Action: Monitor for any deterioration (rot) and replace as required
