the **play inspection** company

Annual Inspection

Mid Suffolk District Council

Beyton Parish Council - The Green

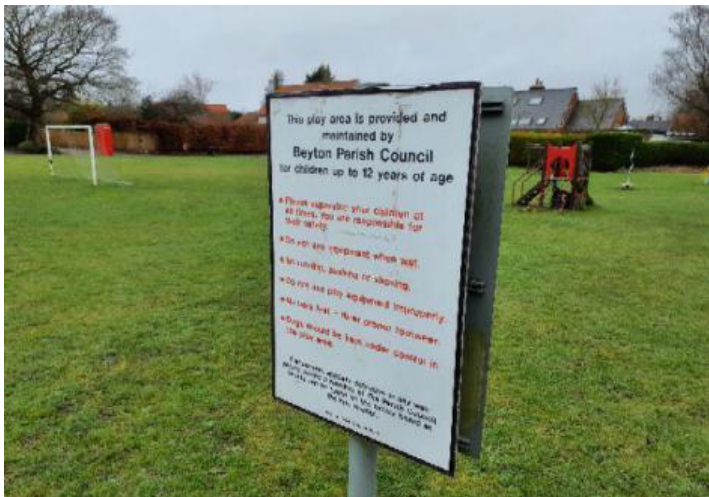
Finding: It is recommended that signage, with information including the site address, contact information for maintenance issues and emergency contact details are provided for the facility
Action: Provide in accordance with the recommendations

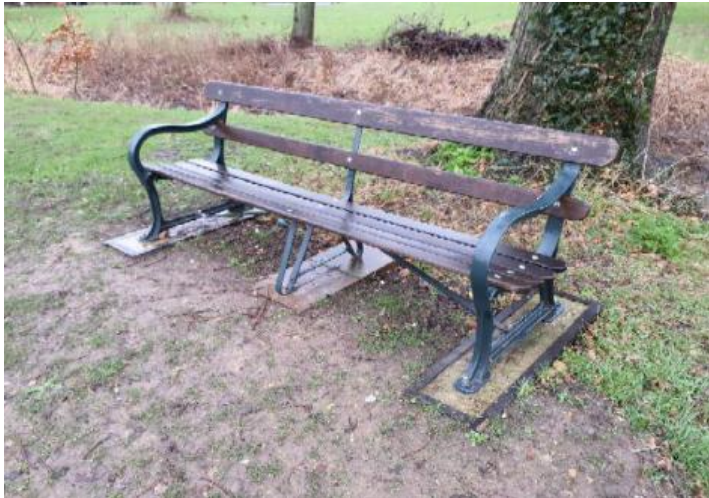
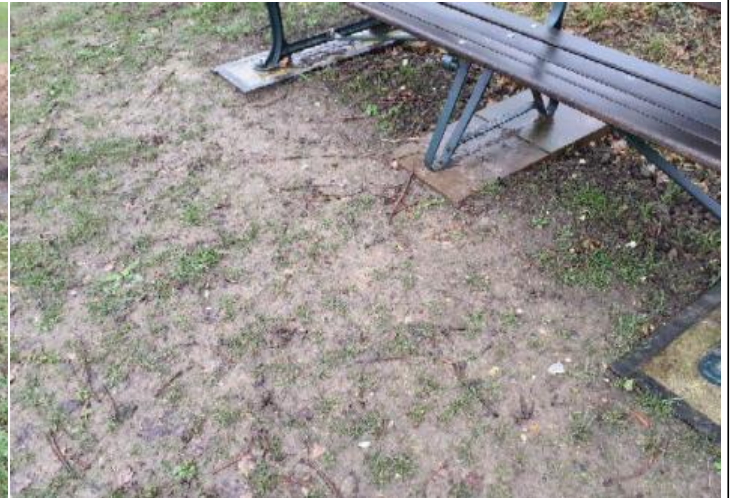
Finding: The surface has eroded in some areas and may be slippery in wet conditions
Action: Reinststate the surface

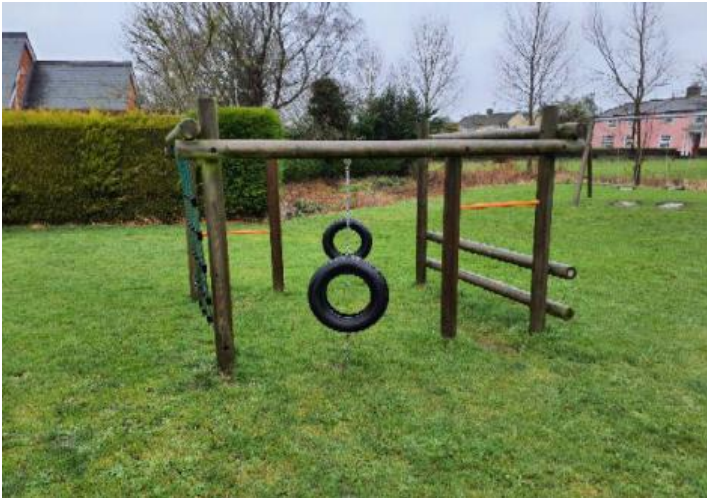
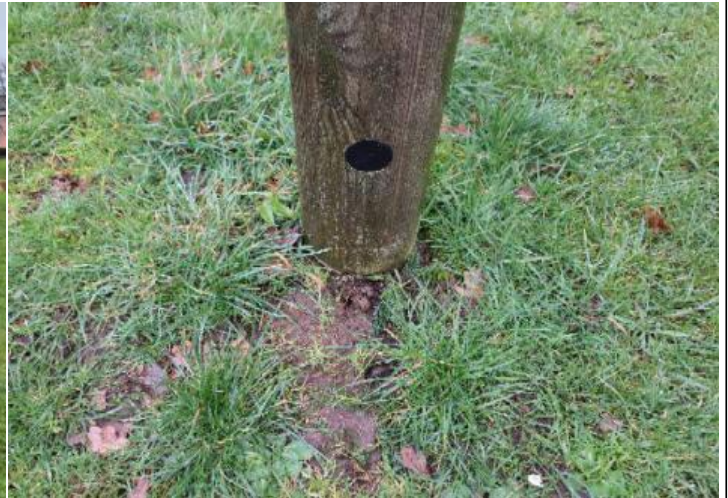
Finding: There is some strimmer / machinery damage apparent on the posts, this can penetrate the preservative applied to the timber and accelerate the rotting process

Action: Monitor for any deterioration (rot) and replace as required

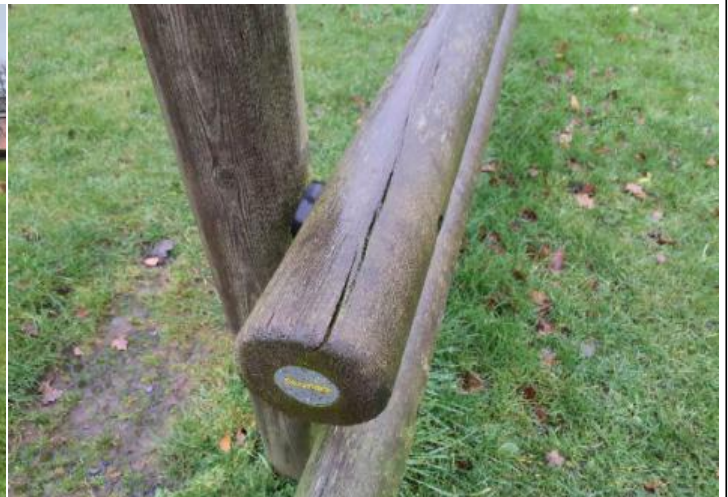
Finding: The timber has a number of splits/shakes or air cracks and this may affect the stability or allow water ingress which will accelerate the rotting process

Action: Monitor to ensure the splits do not cross through fixing points of the structure and/or cause any instability

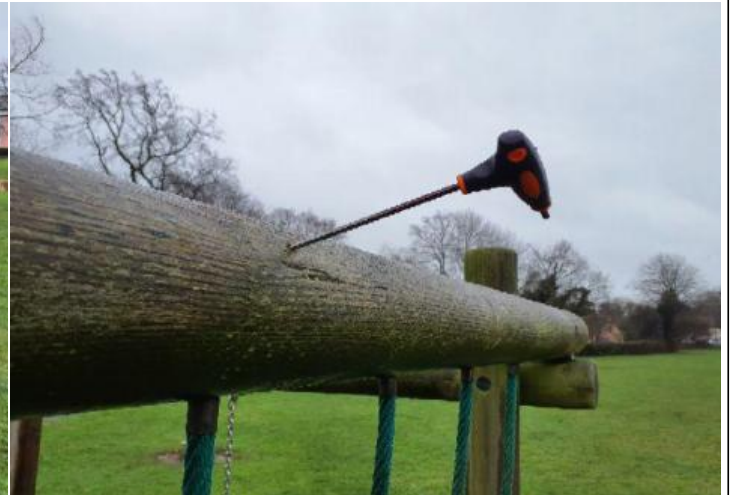
Finding: There is some evidence of rot in the timber

Action: Monitor for any further deterioration and replace as required

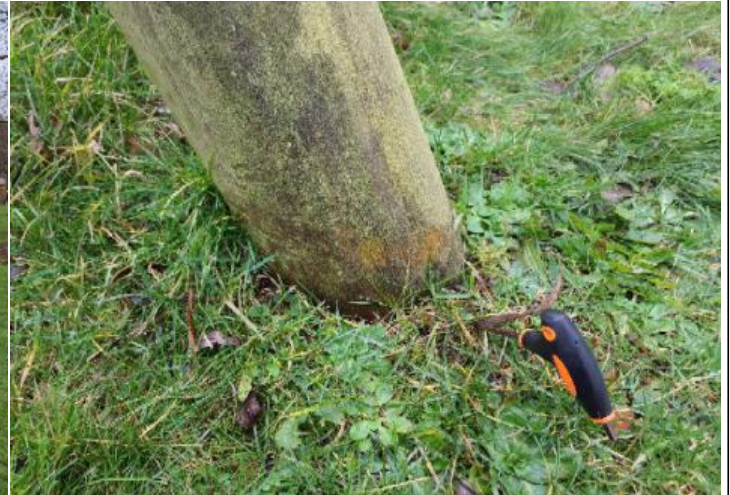
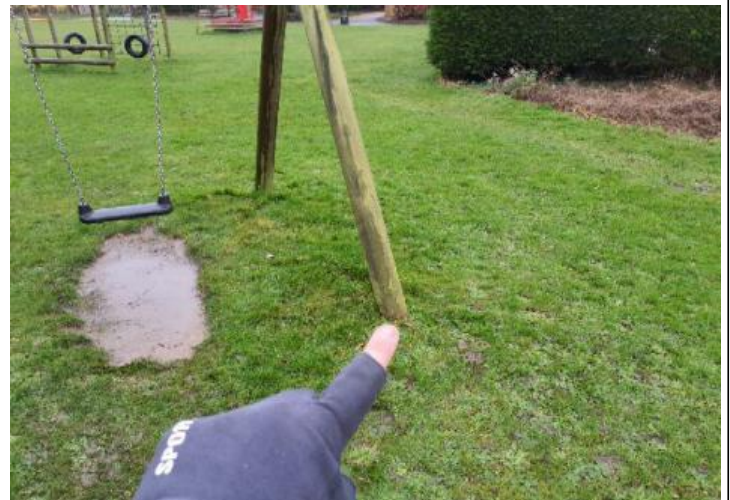
Finding: There are areas or parts of the timber on the structure that have rotted

Action: Replace all affected timbers

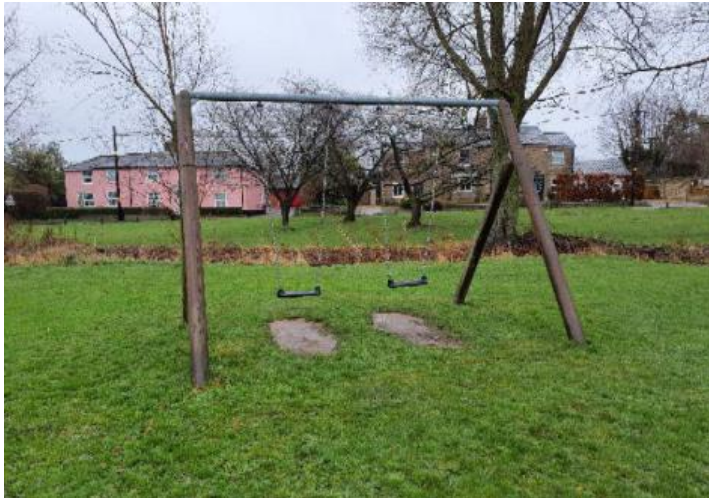
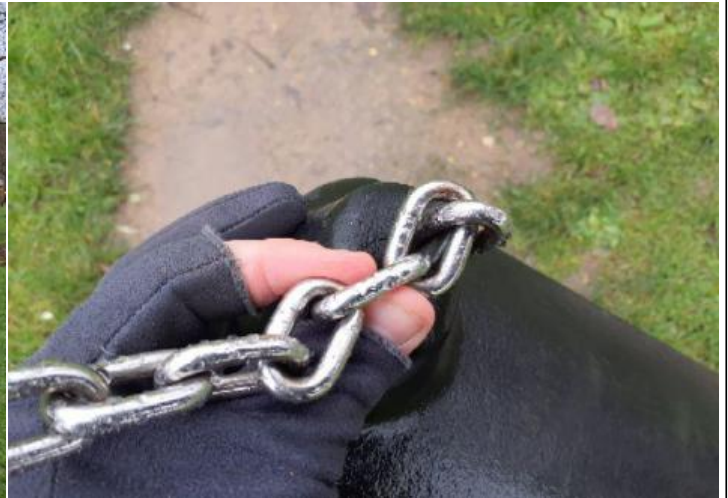
Finding: There is some notable evidence of chain wear

Action: Monitor for any further deterioration and replace when 40% worn

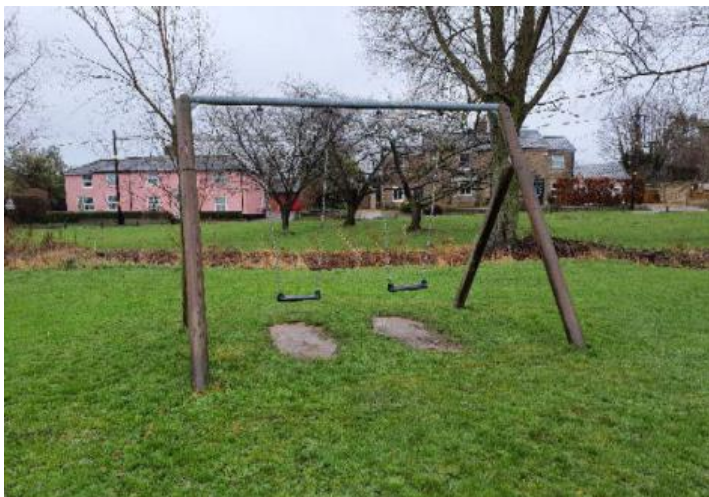
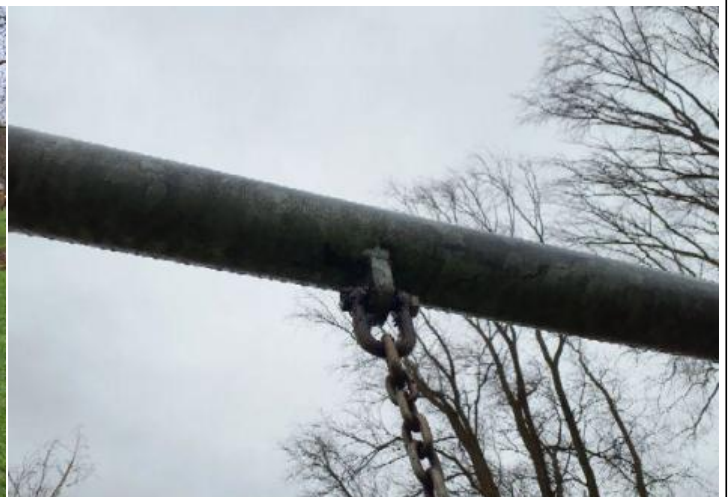
Finding: The bushes are worn or missing

Action: Replace worn or missing bushes

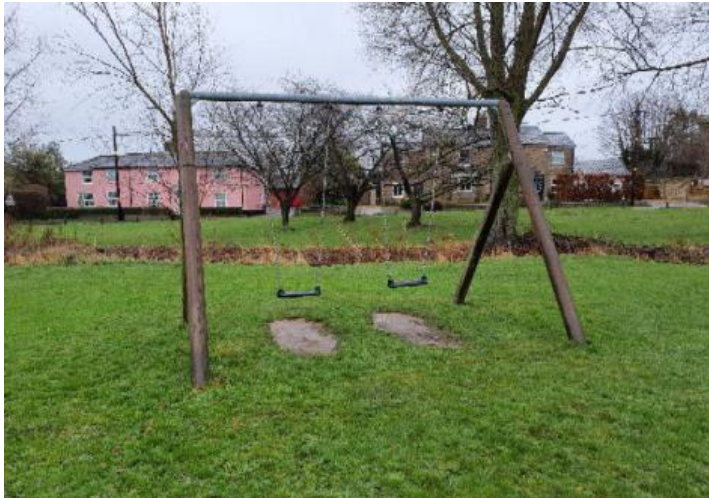
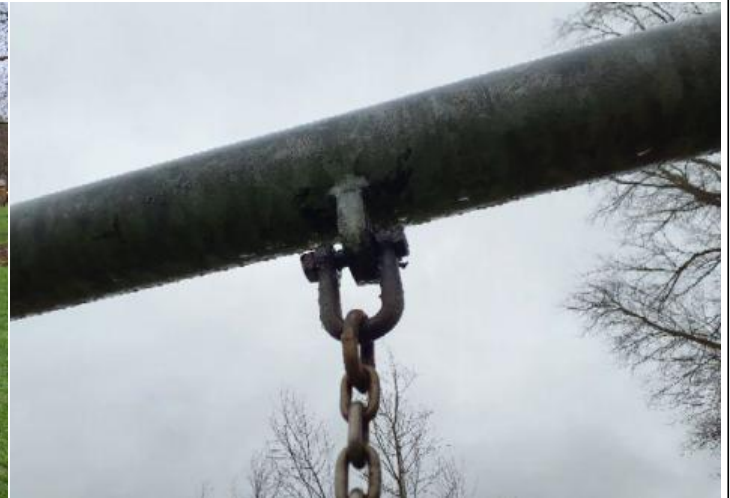
Finding: There is some wear to the shackles

Action: Monitor for any further deterioration and replace when 40% worn

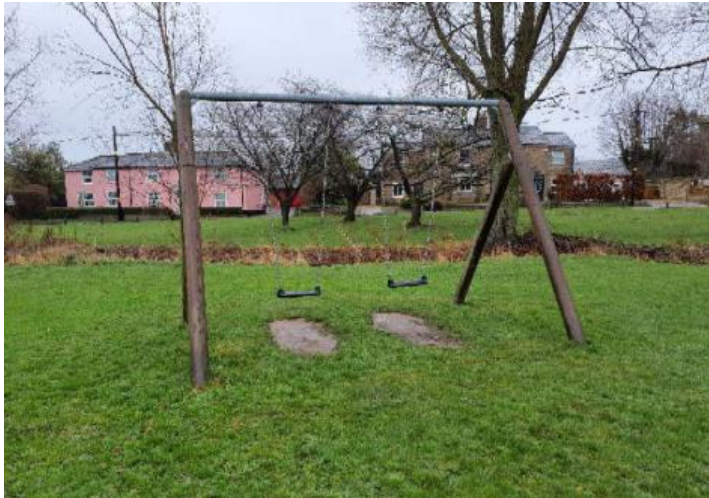
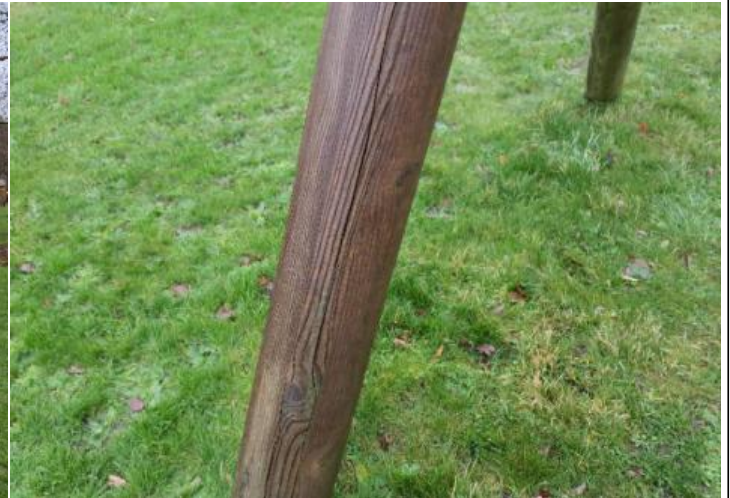
Finding: The timber has a number of splits/shakes or air cracks and this may affect the stability or allow water ingress which will accelerate the rotting process
Action: Monitor to ensure the splits do not cross through fixing points of the structure and/or cause any instability

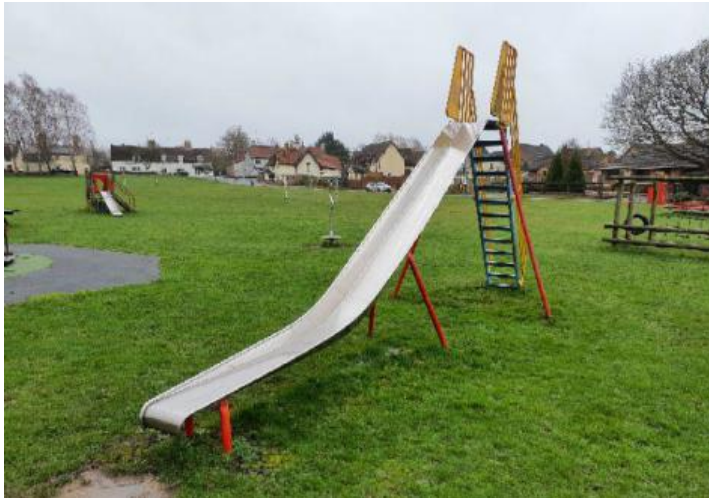
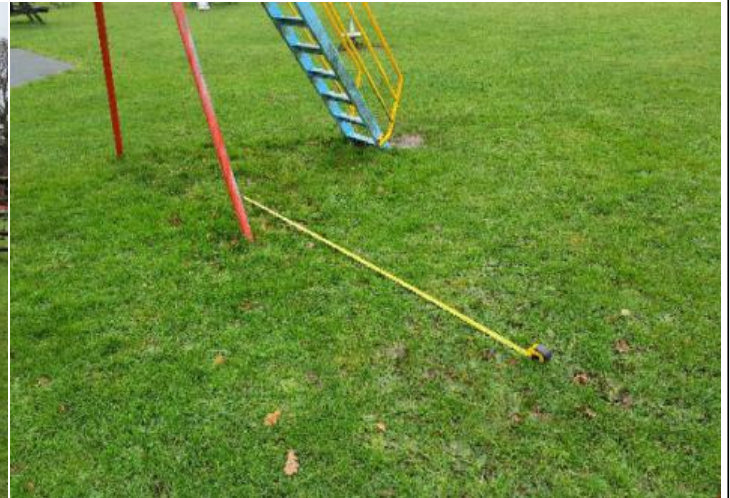
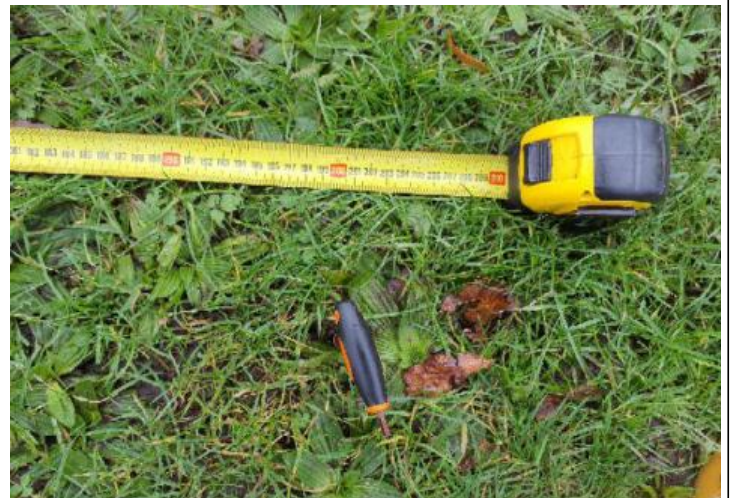
Finding: The surfacing dimensions are short and do not meet with the requirements of the current applicable standard

Action: Monitor - no remedial action recommended

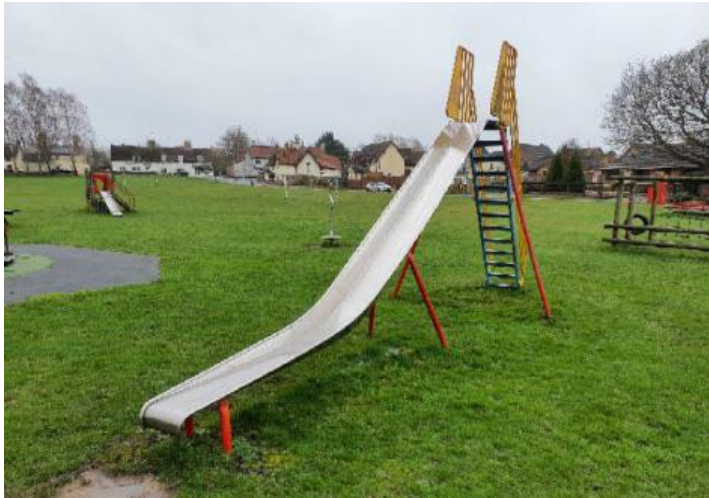
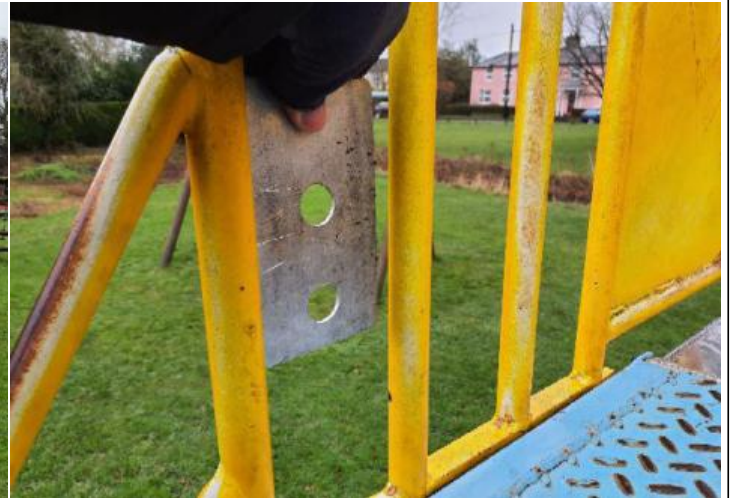
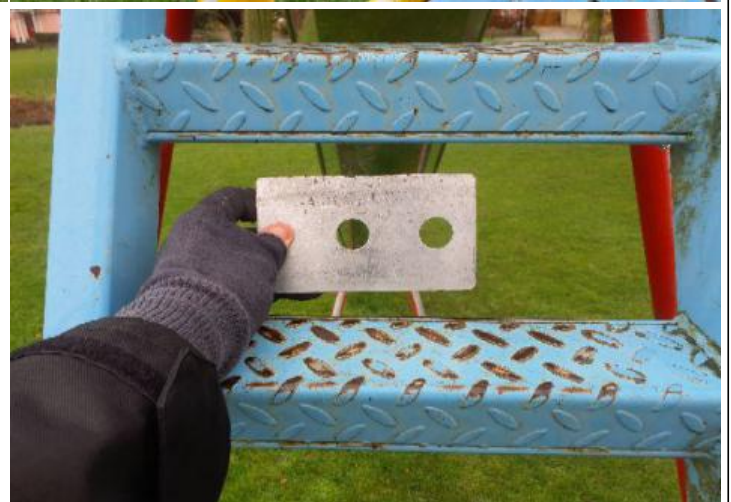
Finding: The item fails to meet the requirements of BS EN 1176 Part 1 4.2.7.2 head and neck entrapment in the barriers and/or steps

Action: Monitor - No remedial work recommended

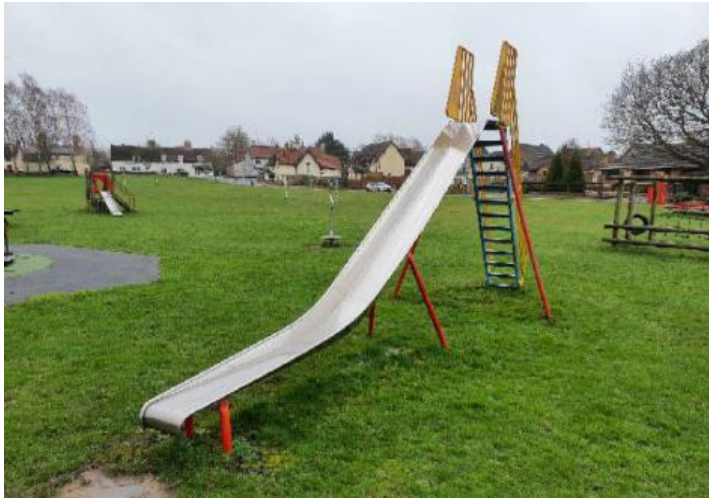
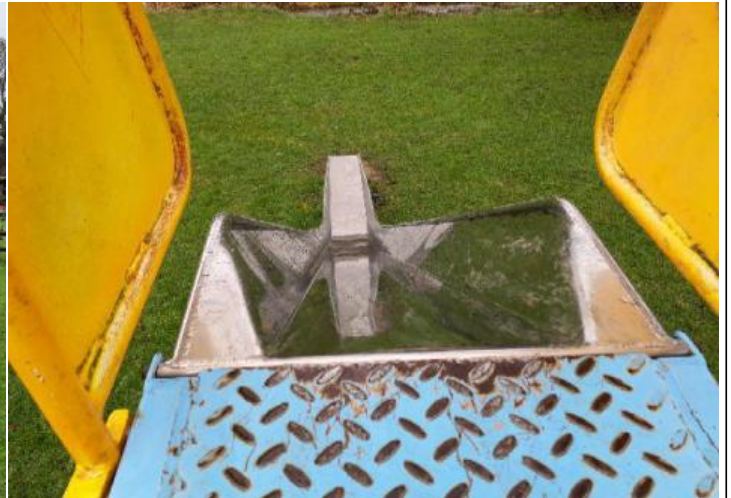
Finding: There are a number of dents in the slide surface

Action: Monitor for any further deterioration and repair as required

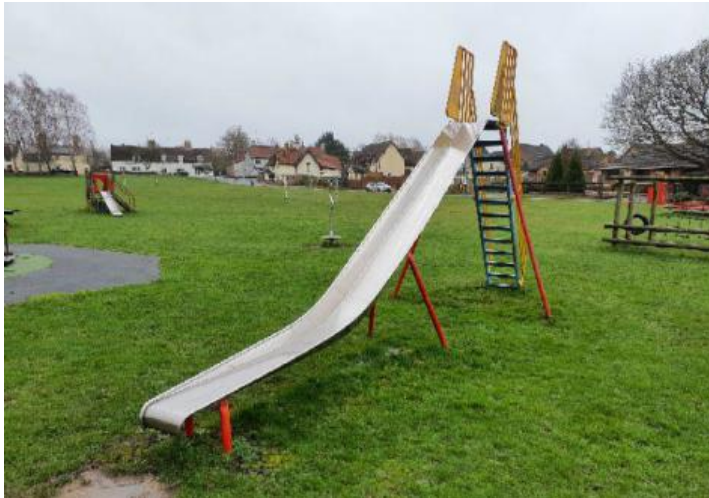
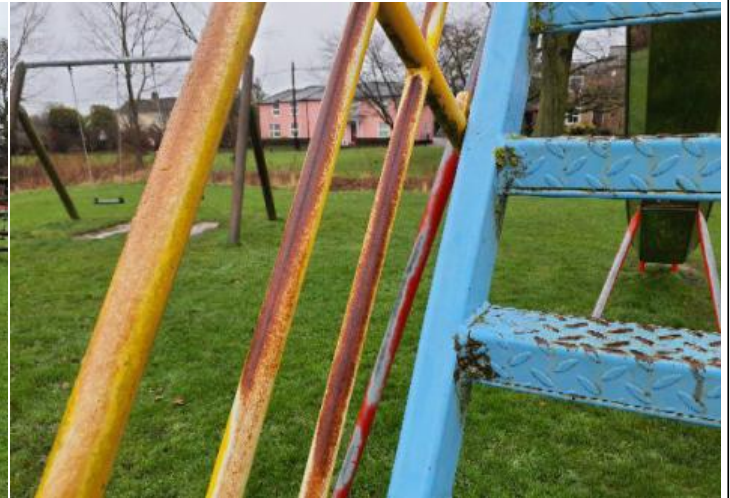
Finding: The paintwork on this item has been damaged or worn exposing the metal underneath which is rusting / corroding

Action: Treat affected areas and repaint

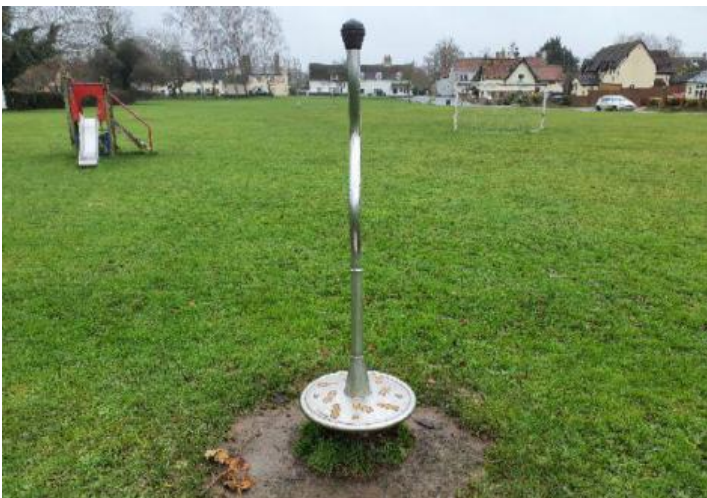
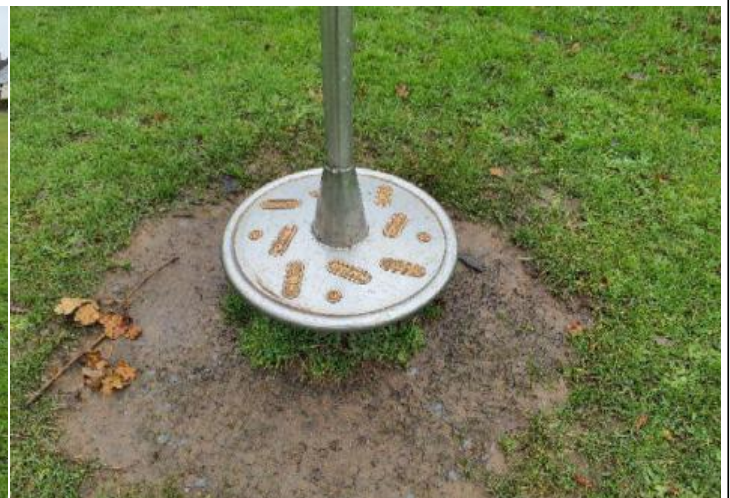
Finding: The bearing is worn / damaged and the item is not operating correctly

Action: Repair / replace

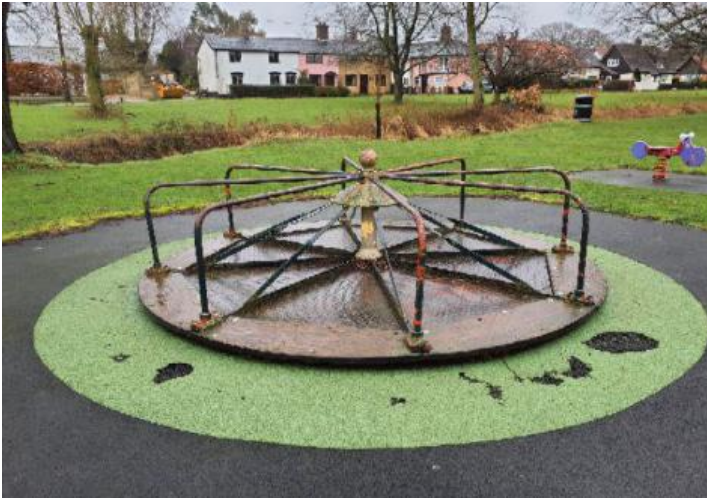
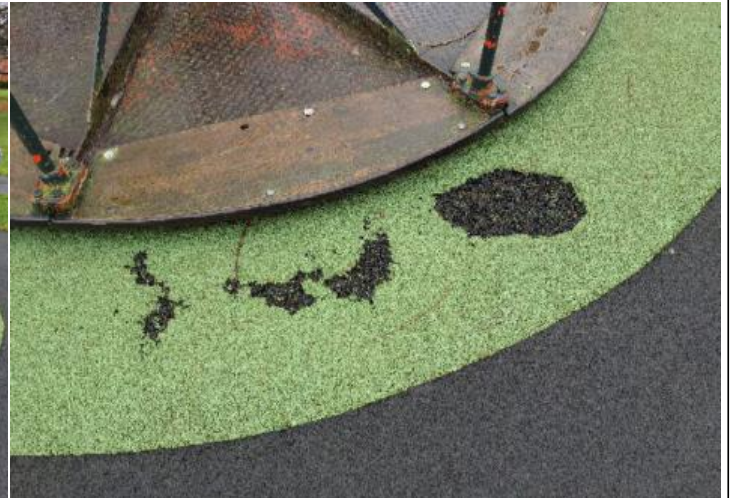
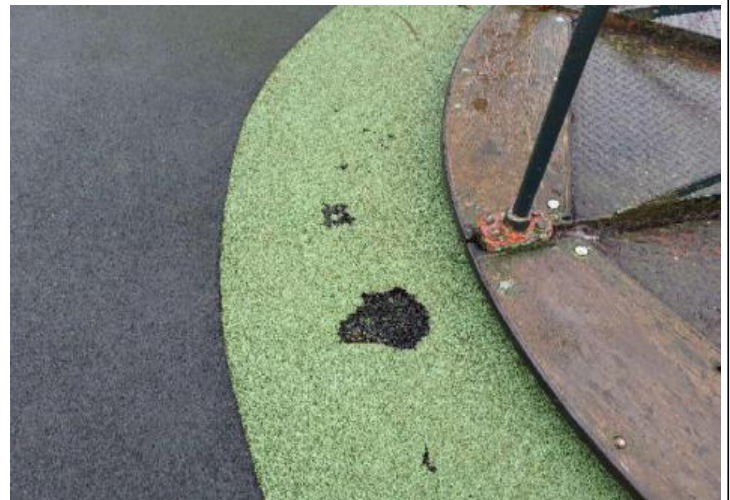
Finding: There is moderate damage to the surface

Action: Repair the damaged areas of surfacing

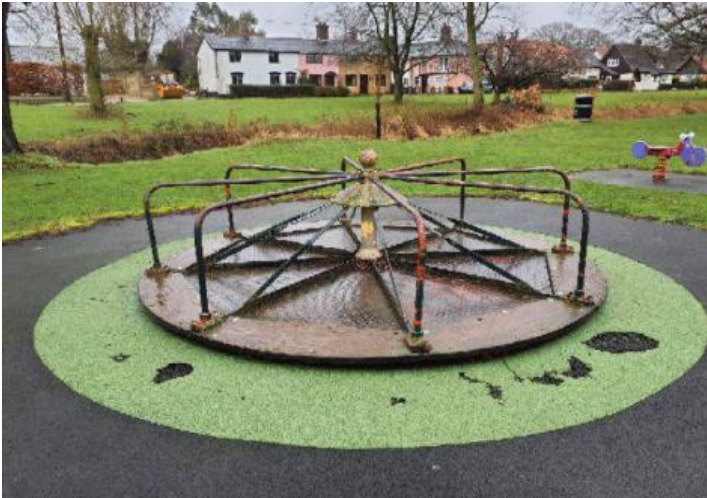
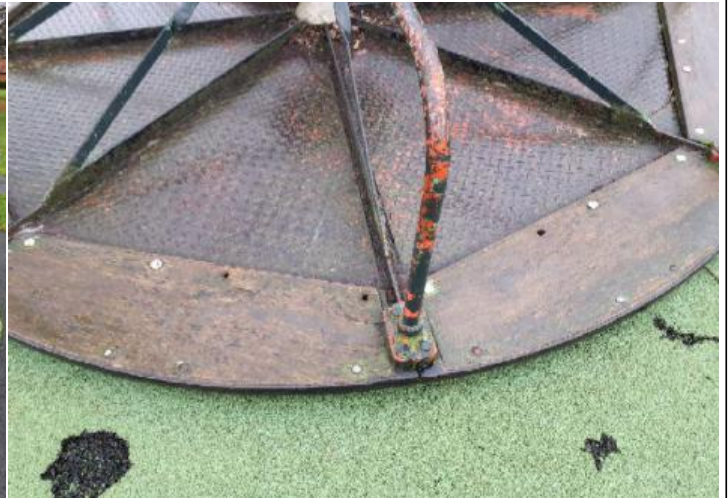
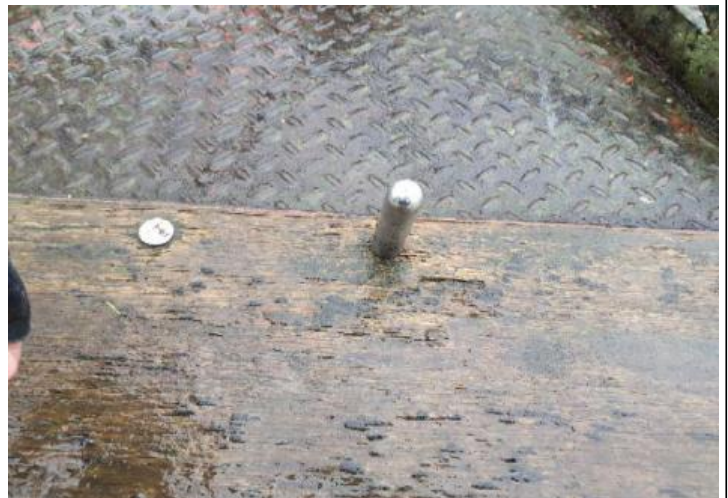
Finding: There is/are finger entrapment/s in the platform due to missing fixings and the item fails to meet the requirements of BS EN 1176 Part 1 4.2.7.6 Entrapment of fingers

Action: Provide missing fixings to remove entrapment

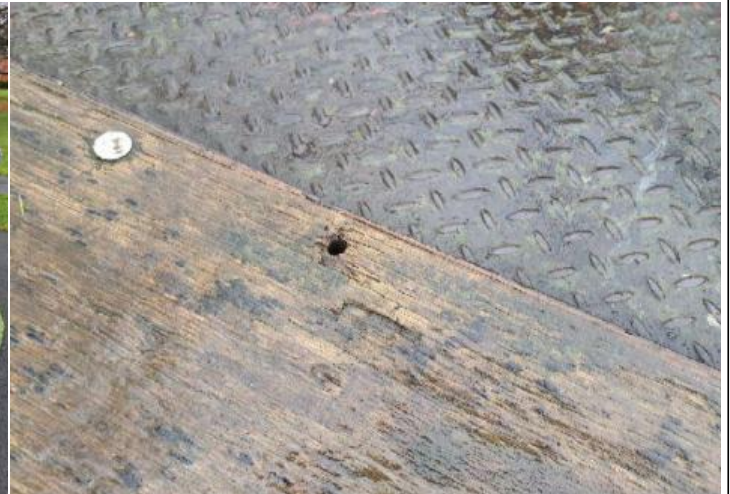
Finding: There is some evidence of rot in the timber

Action: Monitor for any further deterioration and replace as required

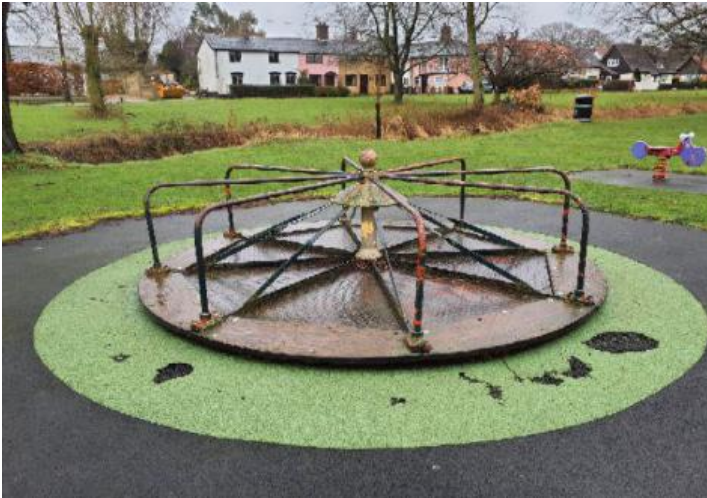
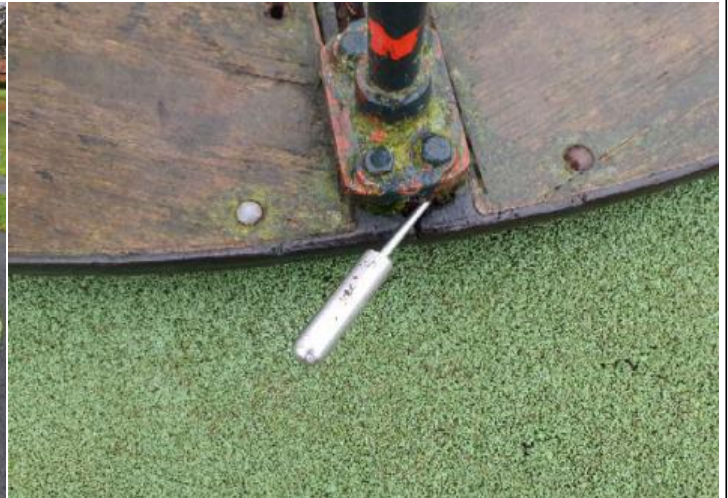
Finding: There is/are finger entrapment/s in the frame and the item fails to meet the requirements of BS EN 1176 Part 1 4.2.7.6 Entrapment of fingers

Action: Monitor - No remedial work recommended

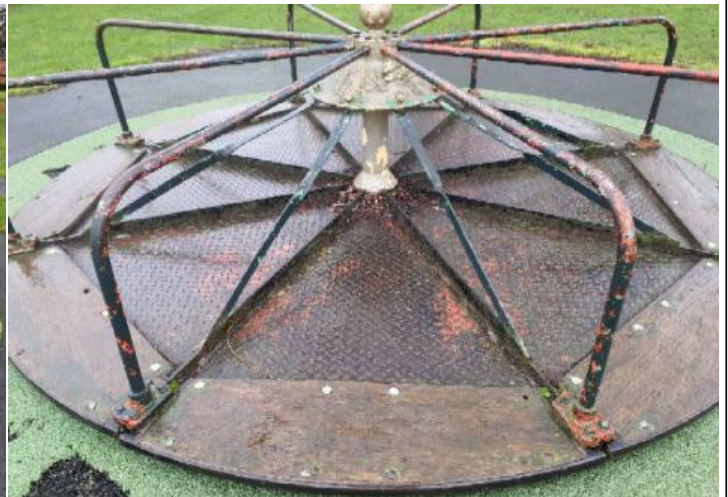
Finding: The bearing is showing signs of wear

Action: Monitor for any further deterioration and replace as required

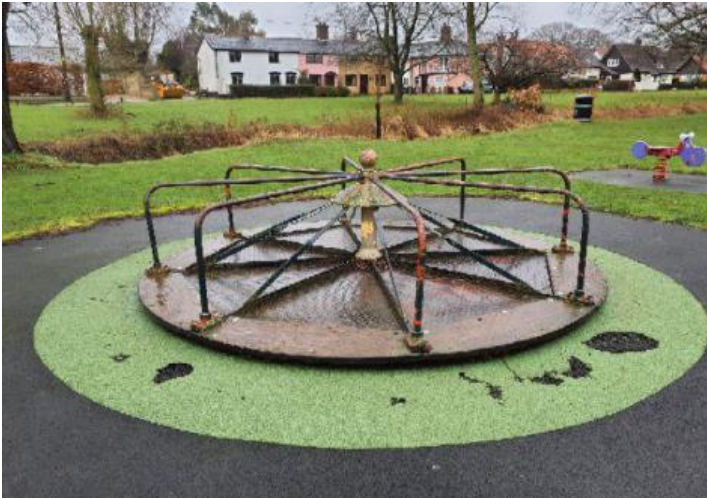
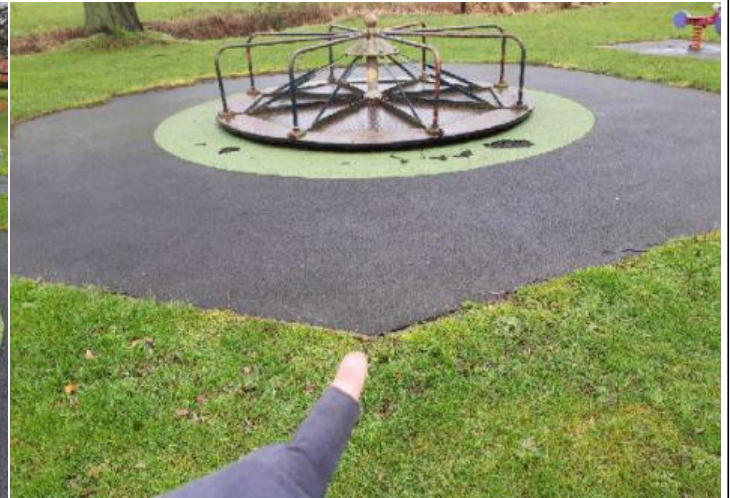
Finding: There are trip hazards at the edges of the surface

Action: Reinstate surrounding surface levels to remove the trip points

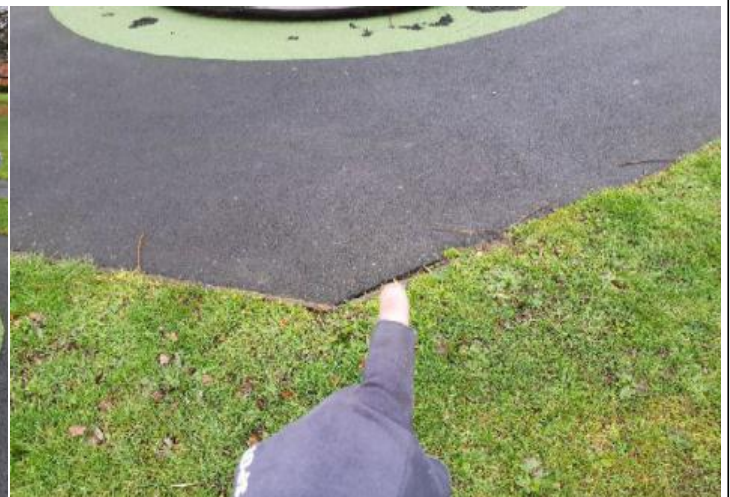
Finding: The surface is lifting at the edges and creating trip points

Action: Repair perimeter of surfacing to remove trip points

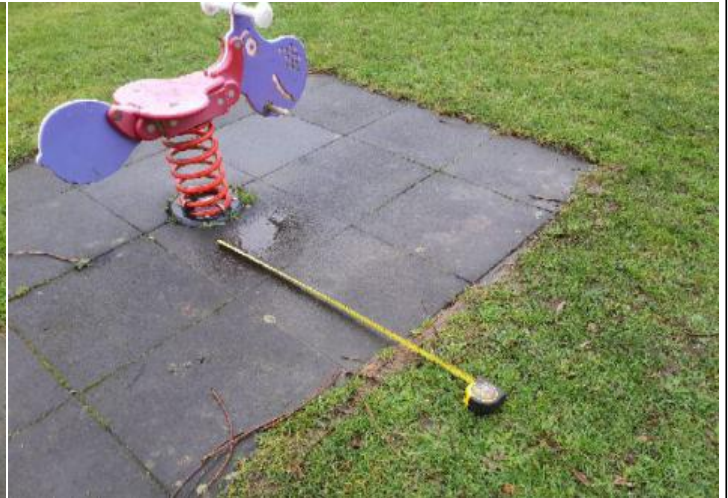
Finding: The timber edge forms a hard object within the impact area of the equipment in contravention of the requirements of BS EN 1176 Part 1

Action: Monitor - No remedial work recommended

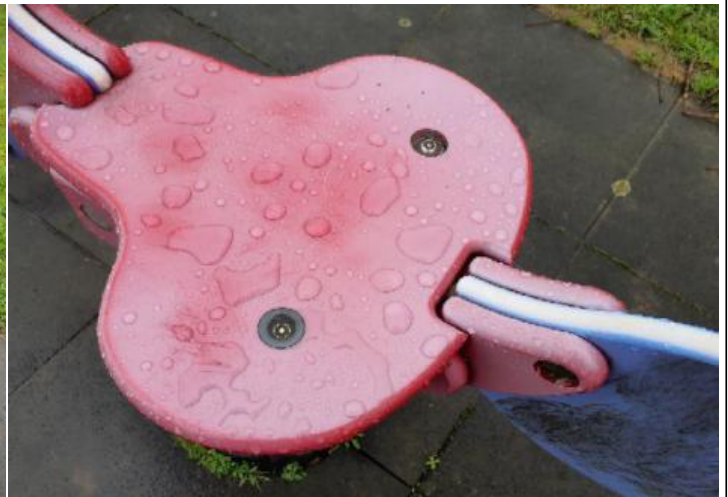
Finding: There is/are bolt cap covers missing or damaged on the item

Action: Replace missing or damaged bolt cap covers

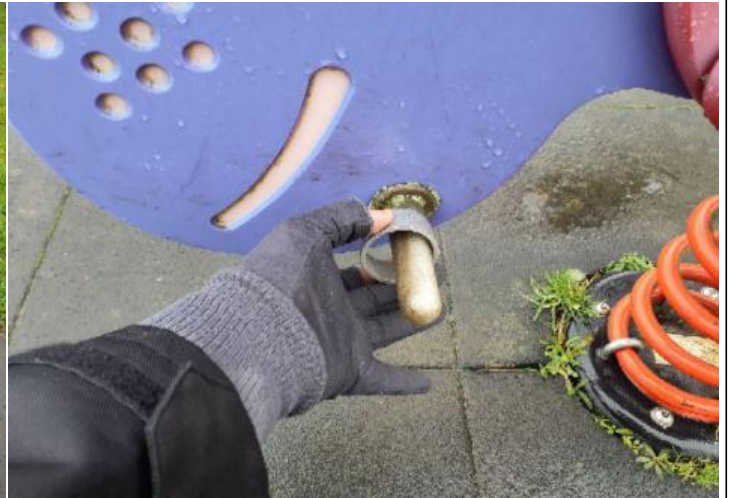
Finding: The end of handgrips and/or footrests have a cross section of less than 15cm² and fail to meet the requirements of BS EN 1176 Part 6
Action: Monitor - No remedial work recommended

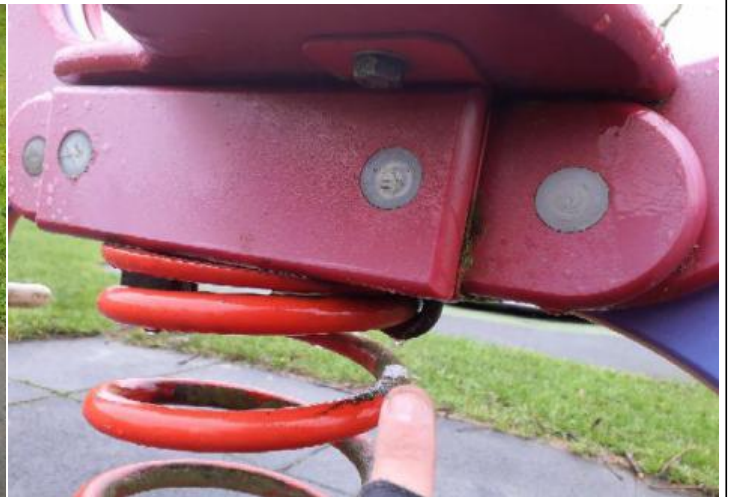
Finding: The spring clamps are loose

Action: Tighten all loose fixings

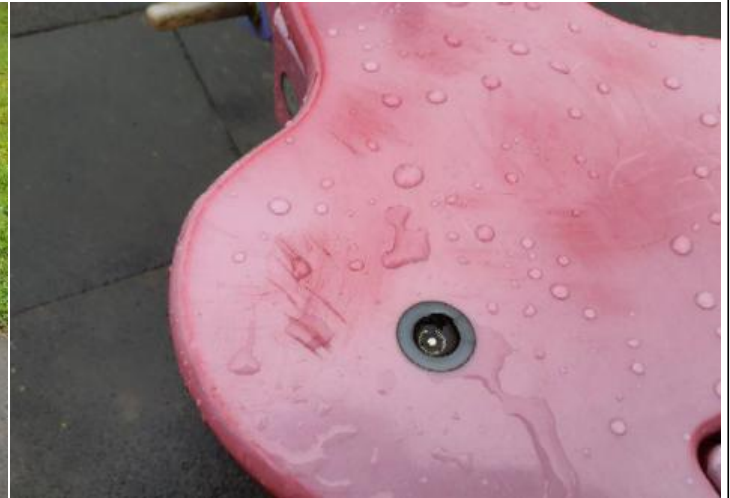
Finding: There is some damage to the item

Action: Monitor for any further deterioration and repair as required

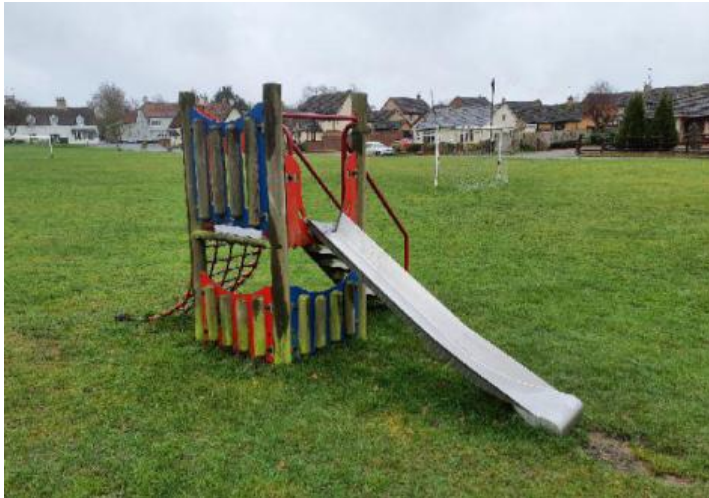
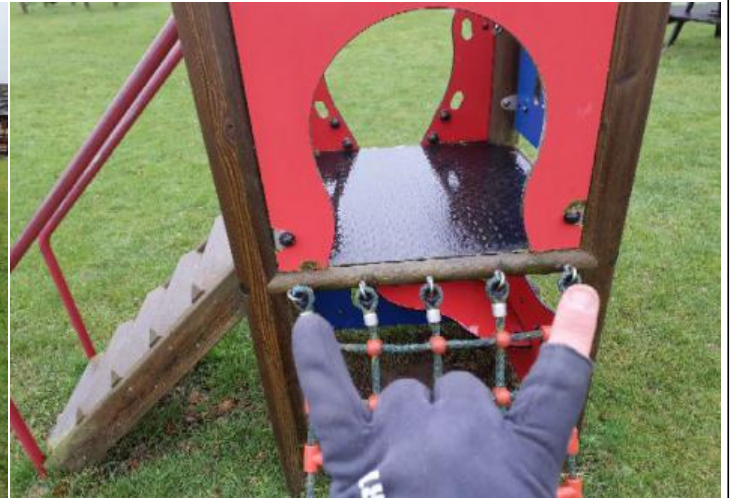
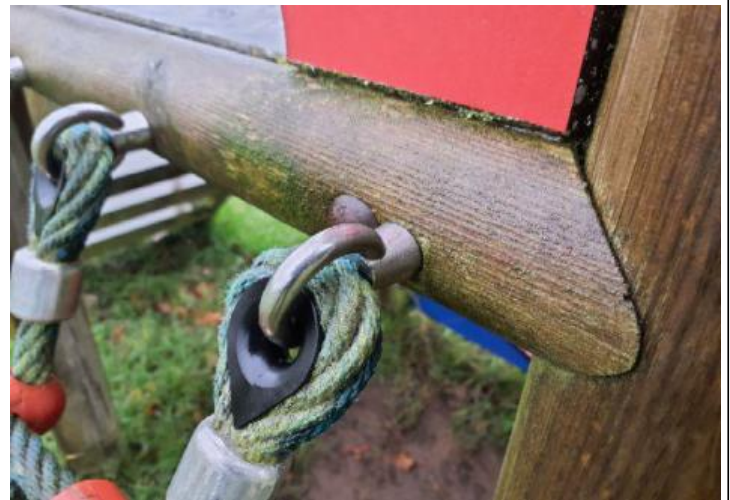
Finding: A number of fixing(s) have worked loose

Action: Secure all loose fixings

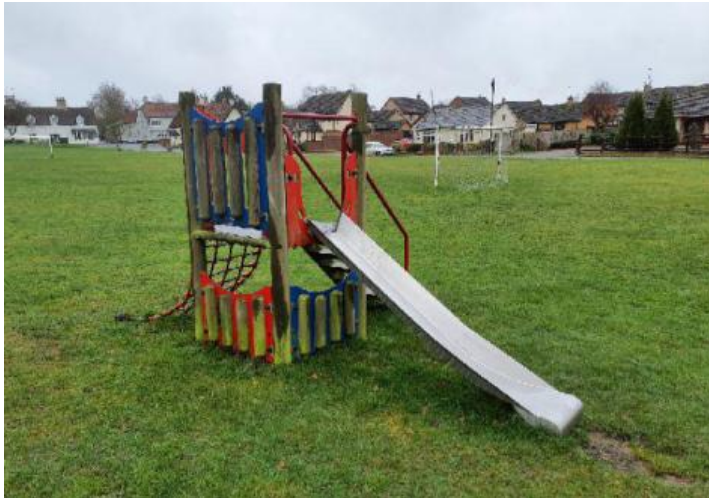
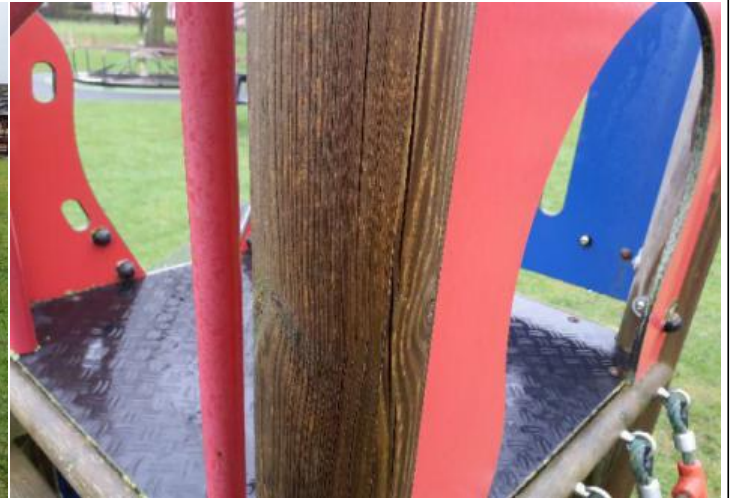
Finding: The timber has a number of splits/shakes or air cracks and this may affect the stability or allow water ingress which will accelerate the rotting process
Action: Monitor to ensure the splits do not cross through fixing points of the structure and/or cause any instability

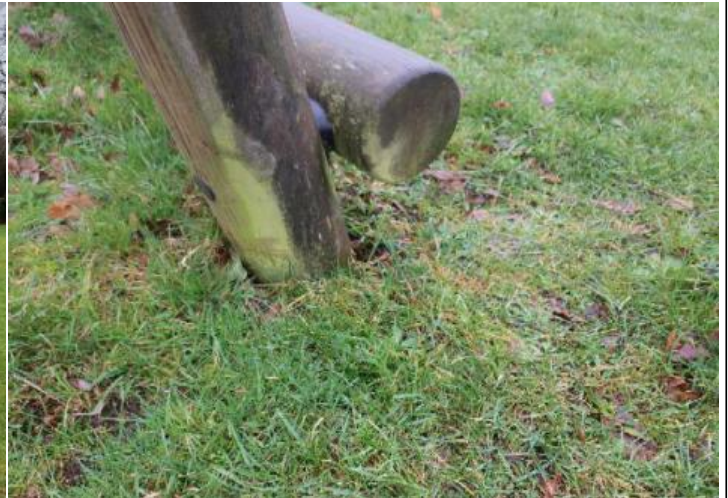
Finding: There is some strimmer / machinery damage apparent on the posts, this can penetrate the preservative applied to the timber and accelerate the rotting process

Action: Monitor for any deterioration (rot) and replace as required

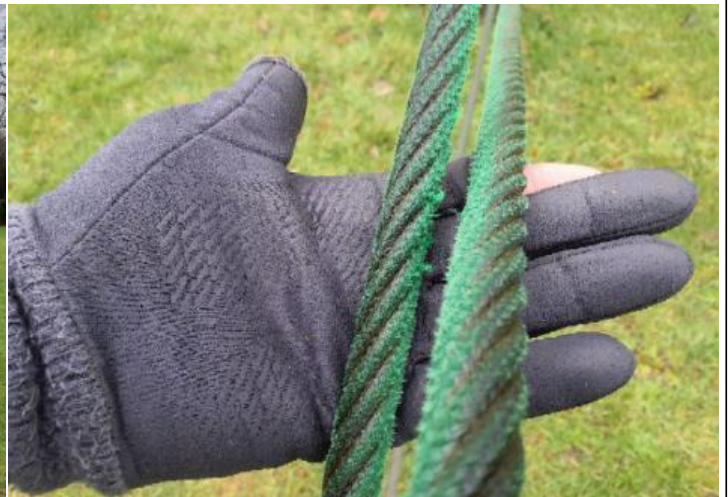
Finding: The ropes/nets are worn/damaged in places

Action: Monitor for any further deterioration and repair or replace as required

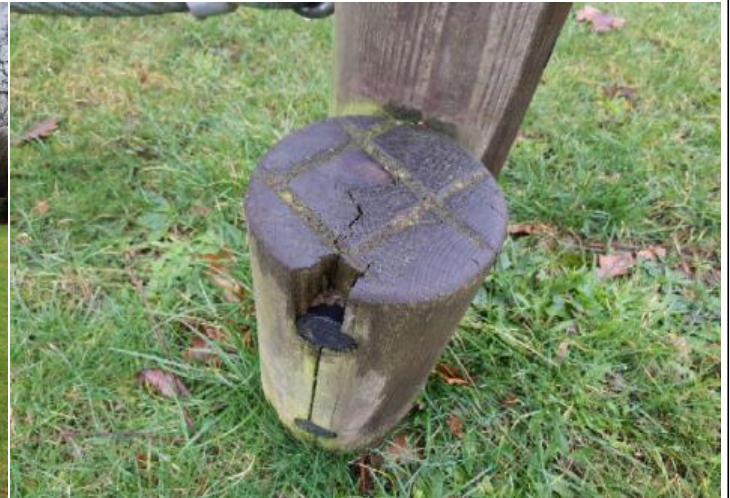
Finding: There is some damage to the item

Action: Monitor for any further deterioration and repair as required

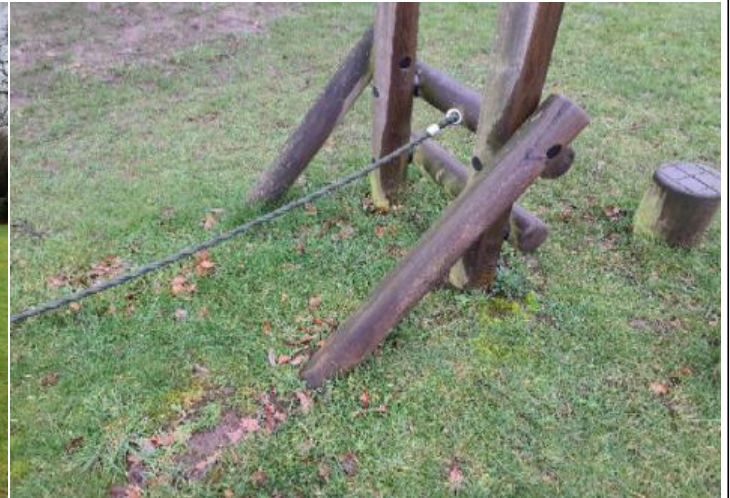
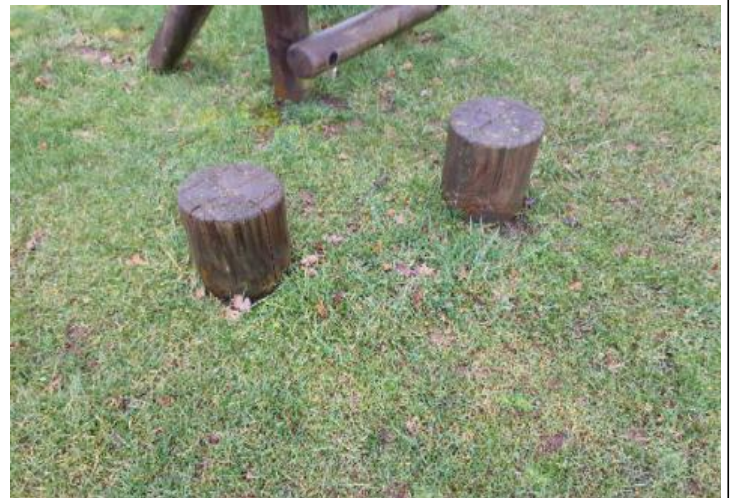
Finding: There is some evidence of rot in the timber

Action: Monitor for any further deterioration and replace as required

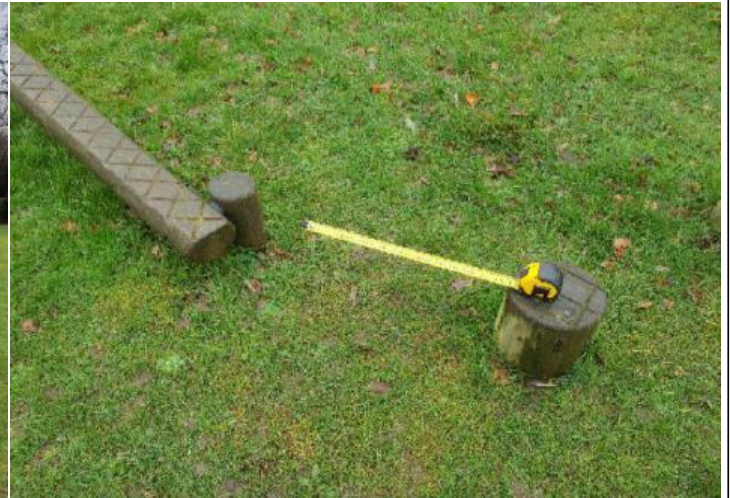
Finding: The step between the items is quite large and users may not be able to complete the step without touching ground, the items could therefore be considered to be within the falling space of each other, however the intention of the play activity continuity is easily apparent and foreseeable to the user

Action: Monitor - No remedial work recommended

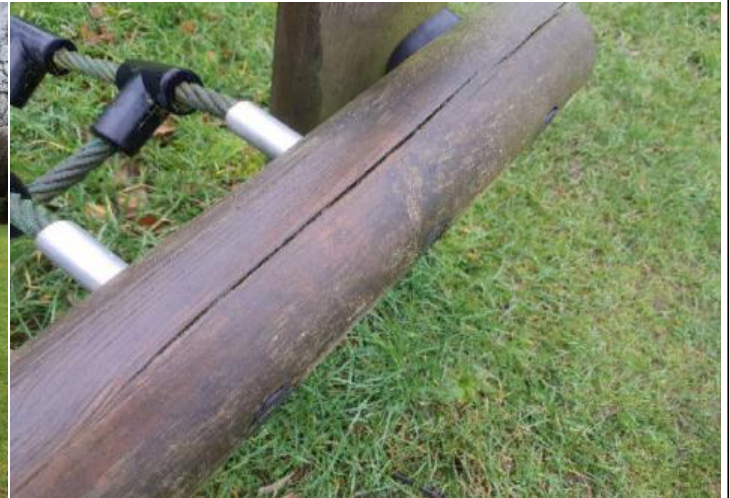
Finding: The timber has a number of splits/shakes or air cracks and this may affect the stability or allow water ingress which will accelerate the rotting process
Action: Monitor to ensure the splits do not cross through fixing points of the structure and/or cause any instability
