the **play inspection** company

Annual Inspection

Mid Suffolk District Council

Beyton Parish Council - The Green

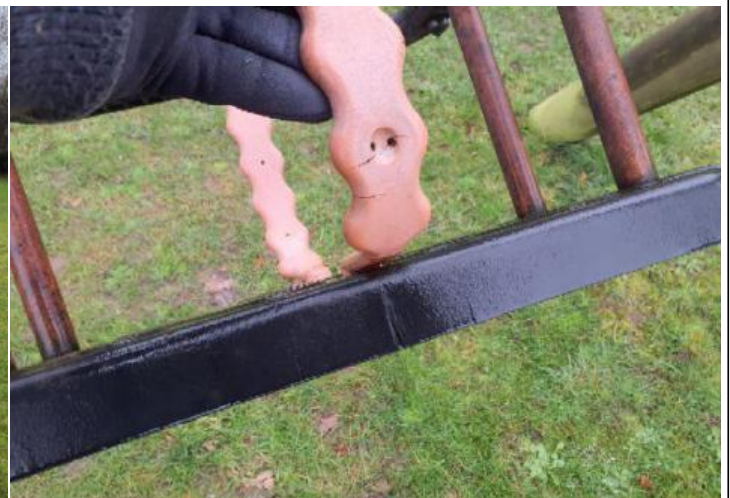
Finding: The seat has minor damage or wear

Action: Monitor for any further deterioration and replace as required

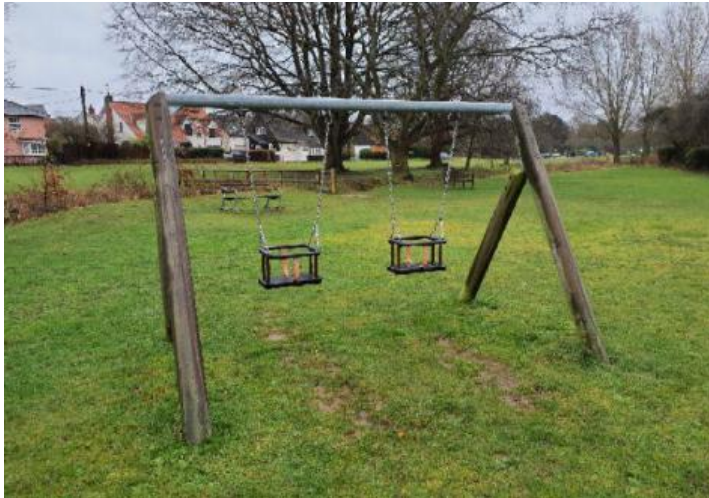
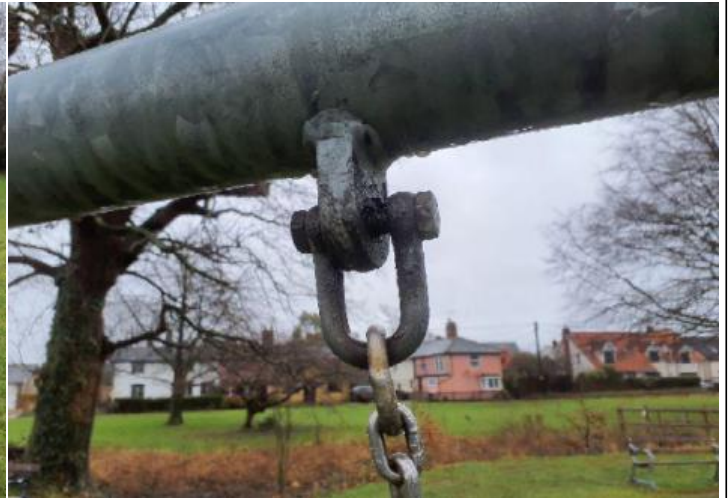
Finding: The bushes are worn or missing

Action: Replace worn or missing bushes

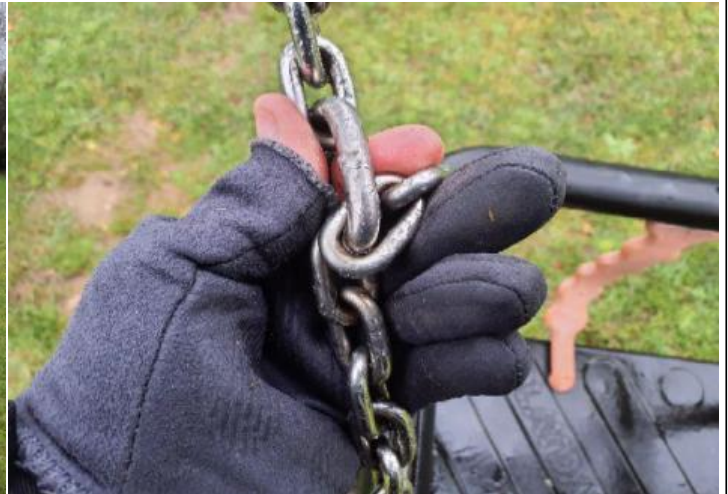
Finding: There is some notable evidence of chain wear

Action: Monitor for any further deterioration and replace when 40% worn

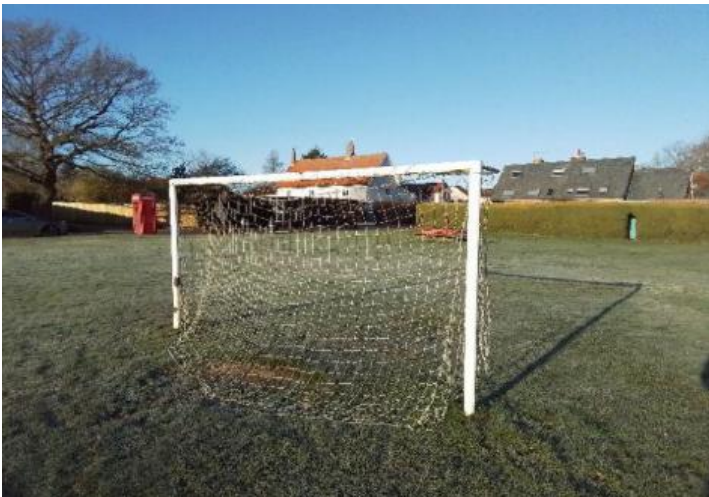
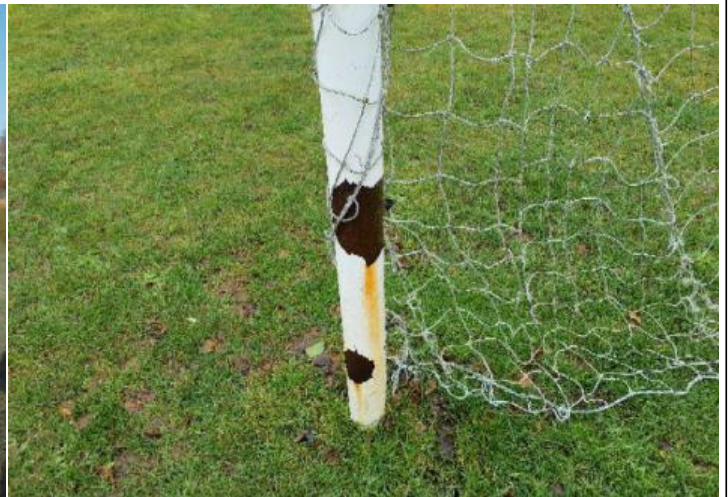
Finding: The paintwork on this item has been damaged or worn exposing the metal underneath which is rusting / corroding

Action: Treat affected areas and repaint

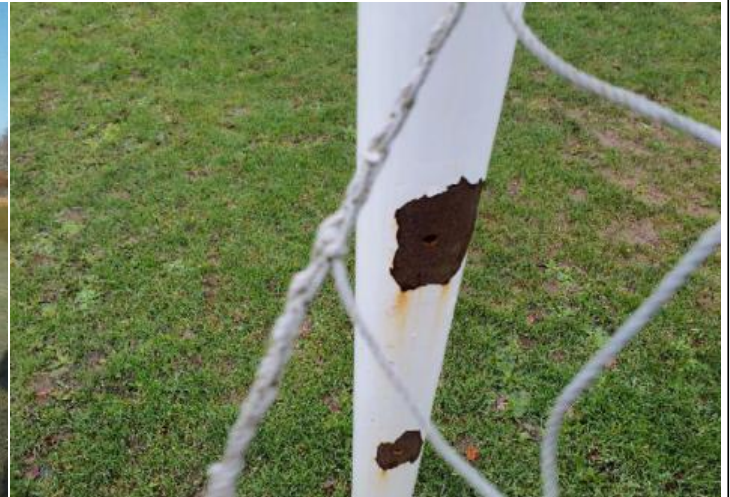
Finding: There is or are fixings missing on the item

Action: Replace all missing fixings

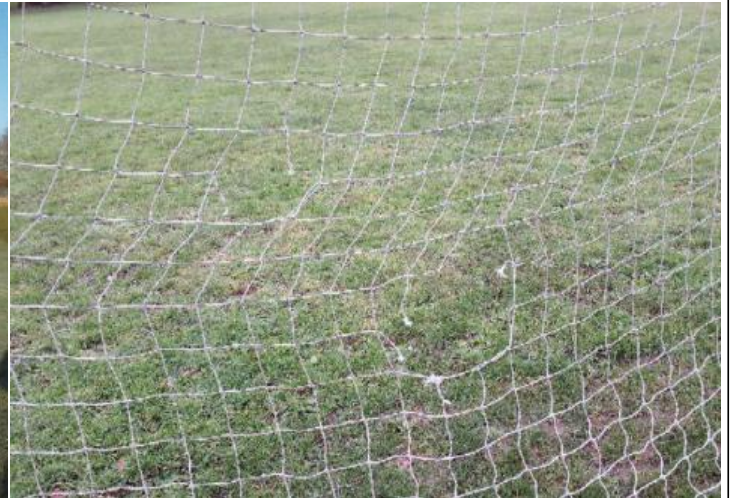
Finding: The nets are damaged

Action: Replace

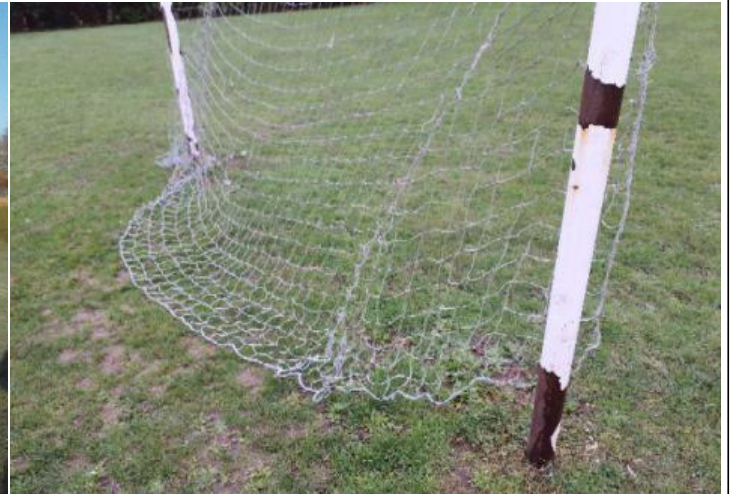
Finding: The item is slightly loose in its foundations

Action: Monitor for any further deterioration and repair as required

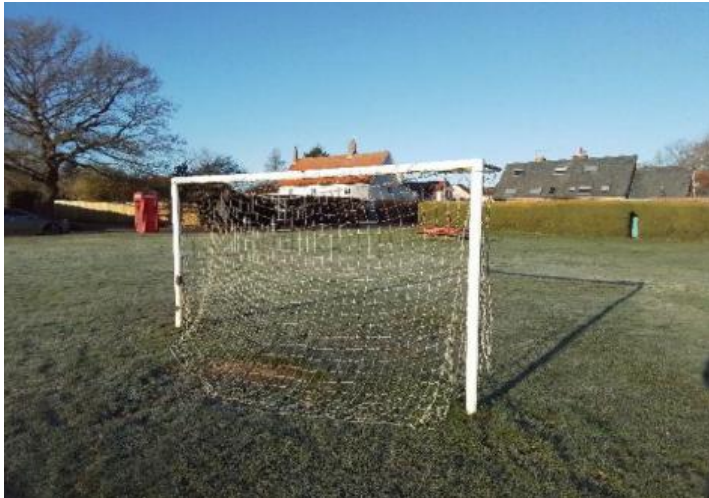
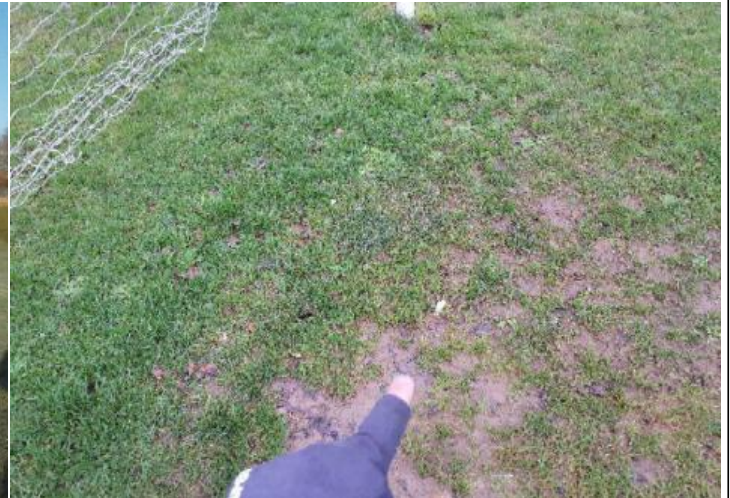
Finding: There is moderate damage to the surface

Action: Repair the damaged areas of surfacing
