Annual Inspection

Mid Suffolk District Council

Beyton

The Green, Suffolk, IP30 9AF

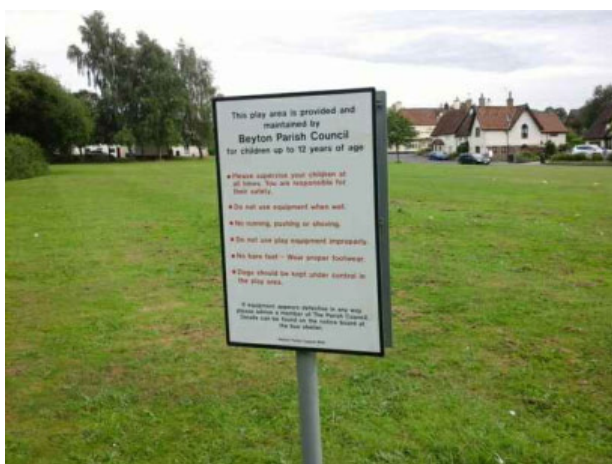
Item: Ancillary Items - Sign
Manufacturer: Unknown
Surface Type: N/A
Equipment Compliance: N/A
Surface Area Compliance: N/A
Ref/Part Number:
Total Findings: 1

This item is satisfactory - no work required

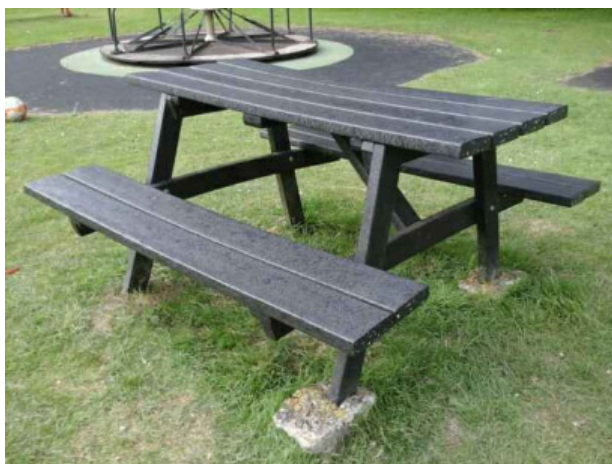
Item: Ancillary Items - Picnic Table
Manufacturer: Owner/Operator
Surface Type: N/A
Equipment Compliance: N/A
Surface Area Compliance: N/A
Ref/Part Number:
Total Findings: 1

This item is satisfactory - no work required

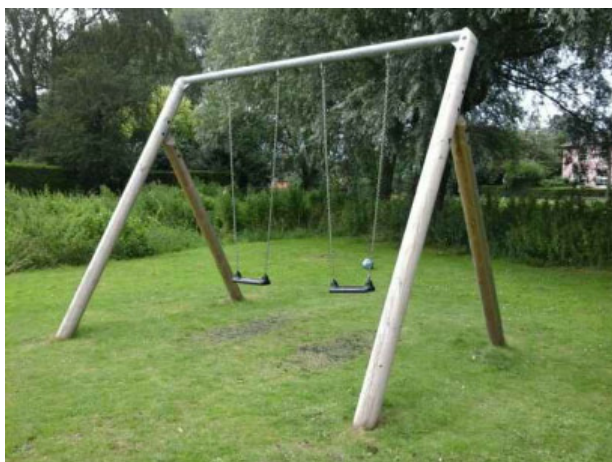
Item: Swings - 1 Bay 2 Seat (Flat)
Manufacturer: Playdale Playgrounds Ltd
Surface Type: Grass Matrix Tiles
Equipment Compliance: Yes
Surface Area Compliance: Yes
Ref/Part Number:
Total Findings: 1

This item is satisfactory - no work required

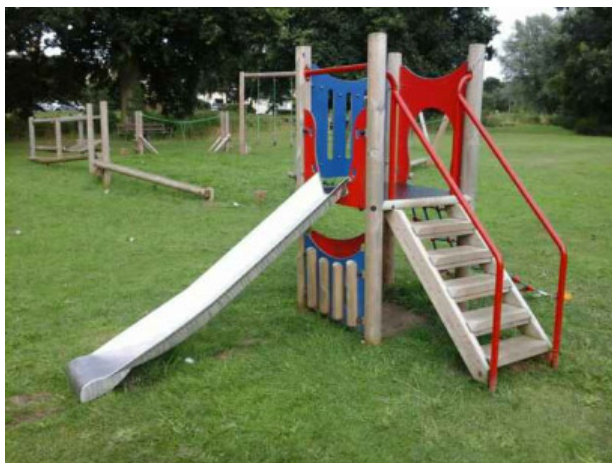
Item: Activity Equipment - Multi Play (Toddler)
Manufacturer: Playdale Playgrounds Ltd
Surface Type: Grass Matrix Tiles
Equipment Compliance: Yes
Surface Area Compliance: Yes
Ref/Part Number:
Total Findings: 1

This item is satisfactory - no work required

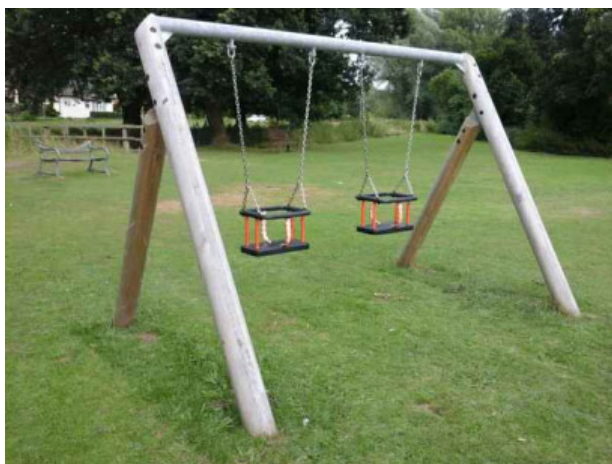
Item: Swings - 1 Bay 2 Seat (Cradle)
Manufacturer: Playdale Playgrounds Ltd
Surface Type: Grass Matrix Tiles
Equipment Compliance: Yes
Surface Area Compliance: Yes
Ref/Part Number:
Total Findings: 1

This item is satisfactory - no work required
