the **play inspection** company

Annual Inspection

Mid Suffolk District Council

Beyton Parish Council - The Green

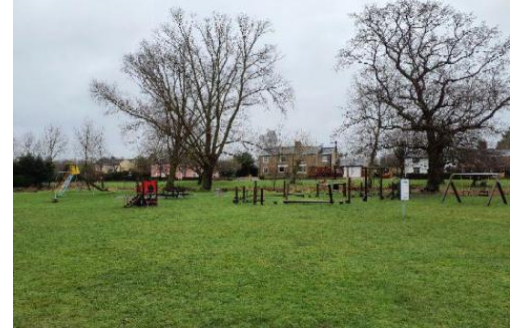
Item: Site General
Manufacturer: Owner/Operator
Surface Type: N/A
Item Quantity: 1
Equipment Compliance: N/A
Surface Area Compliance: N/A

NOTE - There is a body of water or a water basin in close proximity to the playground. Risk assessment of this is a specialist field and outside the scope of our inspection. - Contact our official water safety partner the RLSS (Royal Life Saving Society) at www.rlss.org.uk and / or ensure that the appropriate risk assessment is in place

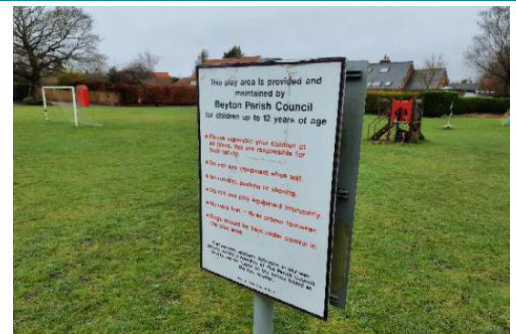
Item: Sign
Manufacturer: Owner/Operator
Surface Type: N/A
Item Quantity: 1
Equipment Compliance: N/A
Surface Area Compliance: N/A

It is recommended that signage, with information including the site address, contact information for maintenance issues and emergency contact details are provided for the facility - Provide in accordance with the recommendations

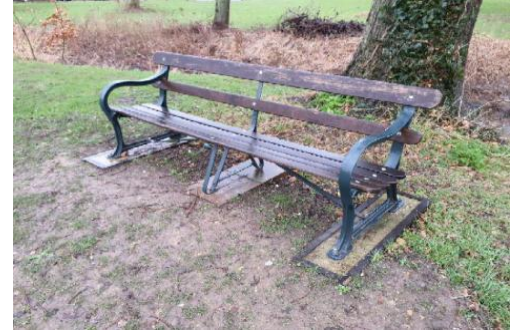
Item: Bench
Manufacturer: Not Identified
Surface Type: Grass
Item Quantity: 1
Equipment Compliance: N/A
Surface Area Compliance: N/A

The surface has eroded in some areas and may be slippery in wet conditions - Reinstate the surface

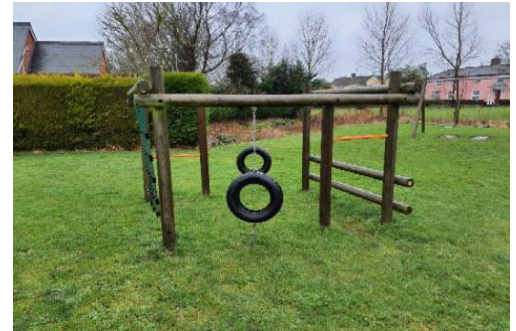
Item: Climbing Frame
Manufacturer: Playdale Playgrounds Ltd
Surface Type: Grass Matrix Tiles
Item Quantity: 1
Equipment Compliance: Yes
Surface Area Compliance: Yes

There is some strimmer / machinery damage apparent on the posts, this can penetrate the preservative applied to the timber and accelerate the rotting process - Monitor for any deterioration (rot) and replace as required

The timber has a number of splits/shakes or air cracks and this may affect the stability or allow water ingress which will accelerate the rotting process - Monitor to ensure the splits do not cross through fixing points of the structure and/or cause any instability

There is some evidence of rot in the timber - Monitor for any further deterioration and replace as required

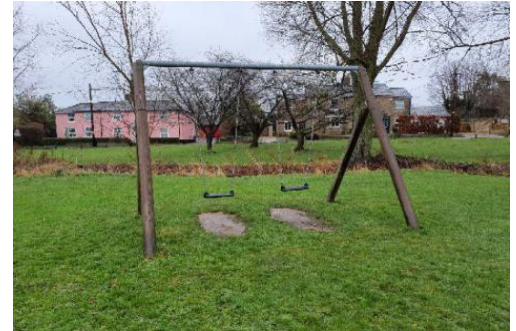
Item: 1 Bay 2 Seat (Flat)
Manufacturer: Playdale Playgrounds Ltd
Surface Type: Grass Matrix Tiles
Item Quantity: 1
Equipment Compliance: Yes
Surface Area Compliance: Yes

There are areas or parts of the timber on the structure that have rotted - Replace all affected timbers

There is some notable evidence of chain wear - Monitor for any further deterioration and replace when 40% worn

The bushes are worn or missing - Replace worn or missing bushes

There is some wear to the shackles - Monitor for any further deterioration and replace when 40% worn

The timber has a number of splits/shakes or air cracks and this may affect the stability or allow water ingress which will accelerate the rotting process - Monitor to ensure the splits do not cross through fixing points of the structure and/or cause any instability

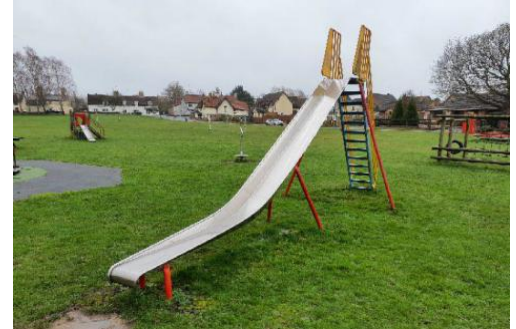
Item: Free Standing Slide
Manufacturer: Not Identified
Surface Type: Grass Matrix Tiles
Item Quantity: 1
Equipment Compliance: No
Surface Area Compliance: No

The grass mats are silted up and the soil is compacted; this may have an effect on the impact absorbing properties of the surface. Consideration should be given to HIC testing the surface to verify impact attenuating properties (<https://playinspections.co.uk/inspection-services/safety-surface-testing/>) - Contact our office for a quotation for this service

The item fails to meet the requirements of BS EN 1176 Part 1 4.2.7.2 head and neck entrapment in the barriers and/or steps - Monitor - No remedial work recommended

The surfacing dimensions are short and do not meet with the requirements of the current applicable standard - Monitor - no remedial action recommended

There are a number of dents in the slide surface - Monitor for any further deterioration and repair as required

The paintwork on this item has been damaged or worn exposing the metal underneath which is rusting / corroding - Treat affected areas and repaint

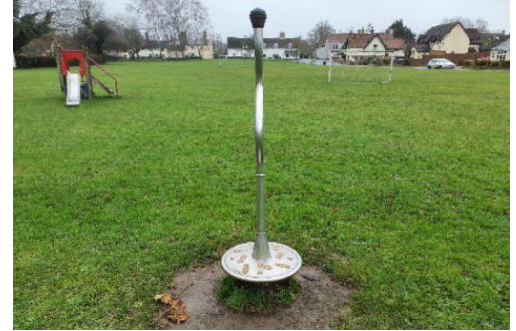
Item: Spinning Pole
Manufacturer: Playdale Playgrounds Ltd
Surface Type: Grass Matrix Tiles
Item Quantity: 1
Equipment Compliance: Yes
Surface Area Compliance: Yes

The grass mats are silted up and the soil is compacted; this may have an effect on the impact absorbing properties of the surface. Consideration should be given to HIC testing the surface to verify impact attenuating properties (<https://playinspections.co.uk/inspection-services/safety-surface-testing/>) - Contact our office for a quotation for this service

The bearing is worn / damaged and the item is not operating correctly - Repair / replace

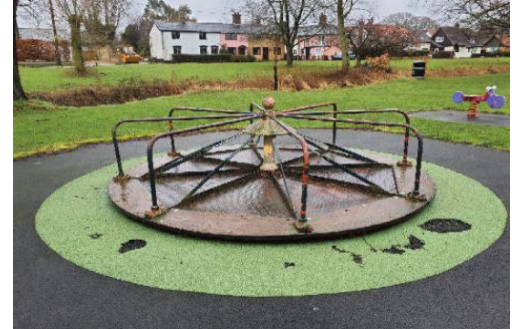
Item: Roundabout
Manufacturer: Wicksteed Playgrounds
Surface Type: Wet Pour
Item Quantity: 1
Equipment Compliance: No
Surface Area Compliance: Yes

There is moderate damage to the surface - Repair the damaged areas of surfacing

There is/are finger entrapment/s in the platform due to missing fixings and the item fails to meet the requirements of BS EN 1176 Part 1 4.2.7.6 Entrapment of fingers - Provide missing fixings to remove entrapment

There is some evidence of rot in the timber - Monitor for any further deterioration and replace as required

There is/are finger entrapment/s in the frame and the item fails to meet the requirements of BS EN 1176 Part 1 4.2.7.6 Entrapment of fingers - Monitor - No remedial work recommended

The bearing is showing signs of wear - Monitor for any further deterioration and replace as required

There are trip hazards at the edges of the surface - Reinststate surrounding surface levels to remove the trip points

The surface is lifting at the edges and creating trip points - Repair perimeter of surfacing to remove trip points

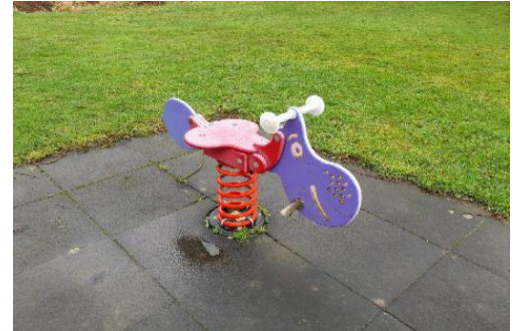
Item: Spring Hippo
Manufacturer: S M P (Playgrounds Ltd)
Surface Type: Rubber Tiles
Item Quantity: 1
Equipment Compliance: No
Surface Area Compliance: No

There is weed / vegetation growth on, between, or around the edges of the surfacing - Remove weed / vegetation growth

There is/are bolt cap covers missing or damaged on the item - Replace missing or damaged bolt cap covers

The spring clamps are loose - Tighten all loose fixings

The timber edge forms a hard object within the impact area of the equipment in contravention of the requirements of BS EN 1176 Part 1 - Monitor - No remedial work recommended

The end of handgrips and/or footrests have a cross section of less than 15cm² and fail to meet the requirements of BS EN 1176 Part 6 - Monitor - No remedial work recommended

There is some damage to the item - Monitor for any further deterioration and repair as required

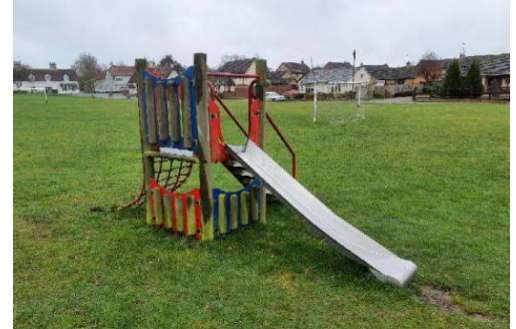
Item: Multi Play (Toddler)
Manufacturer: Playdale Playgrounds Ltd
Surface Type: Grass Matrix Tiles
Item Quantity: 1
Equipment Compliance: Yes
Surface Area Compliance: Yes

A number of fixing(s) have worked loose - Secure all loose fixings

The timber has a number of splits/shakes or air cracks and this may affect the stability or allow water ingress which will accelerate the rotting process - Monitor to ensure the splits do not cross through fixing points of the structure and/or cause any instability

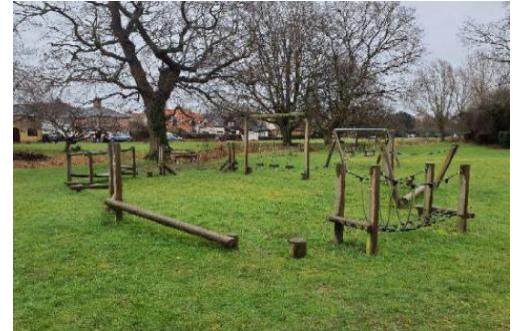
Item: Activity Trail
Manufacturer: Playdale Playgrounds Ltd
Surface Type: Grass Matrix Tiles
Item Quantity: 1
Equipment Compliance: Yes
Surface Area Compliance: Yes

There is algae or moss on the surface of the equipment - Clean and treat appropriately

The ropes/nets are worn/damaged in places - Monitor for any further deterioration and repair or replace as required

There is some evidence of rot in the timber - Monitor for any further deterioration and replace as required

The timber has a number of splits/shakes or air cracks and this may affect the stability or allow water ingress which will accelerate the rotting process - Monitor to ensure the splits do not cross through fixing points of the structure and/or cause any instability

There is some strimmer / machinery damage apparent on the posts, this can penetrate the preservative applied to the timber and accelerate the rotting process - Monitor for any deterioration (rot) and replace as required

There is some damage to the item - Monitor for any further deterioration and repair as required

The step between the items is quite large and users may not be able to complete the step without touching ground, the items could therefore be considered to be within the falling space of each other, however the intention of the play activity continuity is easily apparent and foreseeable to the user - Monitor - No remedial work recommended

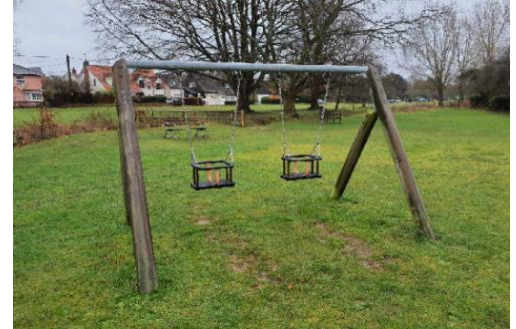
Item: 1 Bay 2 Seat (Cradle)
Manufacturer: Playdale Playgrounds Ltd
Surface Type: Grass Matrix Tiles
Item Quantity: 1
Equipment Compliance: Yes
Surface Area Compliance: Yes

The grass mats are silted up and the soil is compacted; this may have an effect on the impact absorbing properties of the surface. Consideration should be given to HIC testing the surface to verify impact attenuating properties (<https://playinspections.co.uk/inspection-services/safety-surface-testing/>) - Contact our office for a quotation for this service

The seat has minor damage or wear - Monitor for any further deterioration and replace as required

The bushes are worn or missing - Replace worn or missing bushes

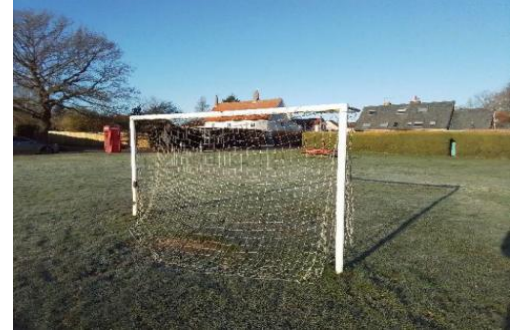
Item: 5 a side Goals
Manufacturer: Not Identified
Surface Type: Grass
Item Quantity: 1
Equipment Compliance: N/A
Surface Area Compliance: N/A

The nets are damaged - Replace

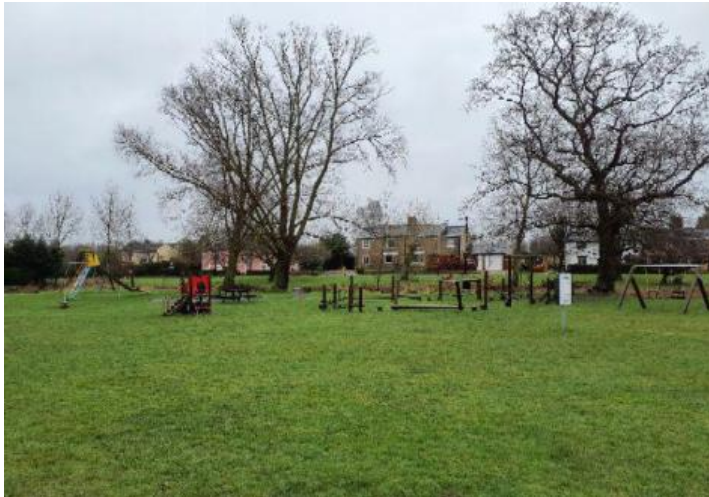
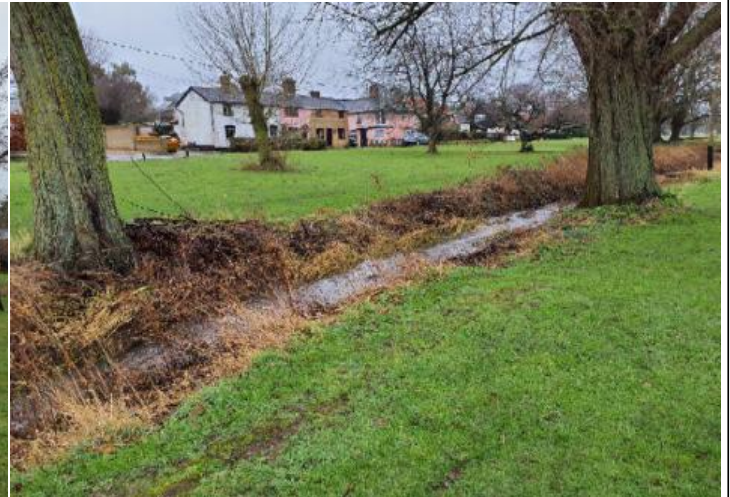
Item: Ancillary Items - Site General
Manufacturer: Owner/Operator

Finding: NOTE - There is a body of water or a water basin in close proximity to the playground. Risk assessment of this is a specialist field and outside the scope of our inspection. **Action:** Contact our official water safety partner the RLSS (Royal Life Saving Society) at www.rlss.org.uk and / or ensure that the appropriate risk assessment is in place

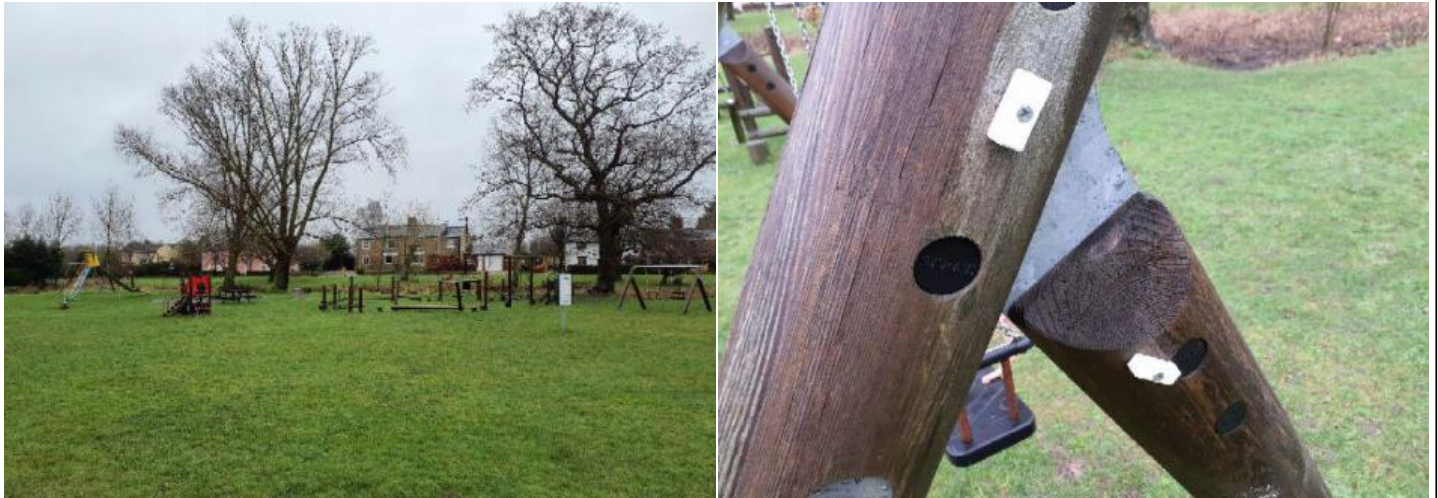
Item: Ancillary Items - Site General
Manufacturer: Owner/Operator
Risk Level: L - Low Risk
Surface: N/A

Finding: There are redundant items on the equipment
Action: Remove

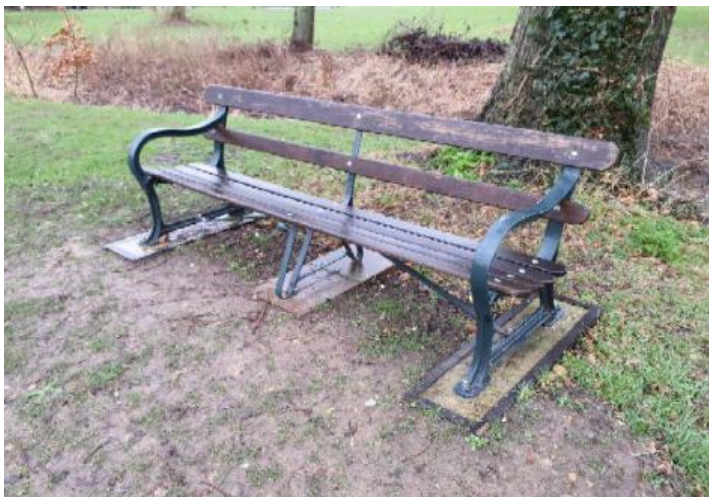
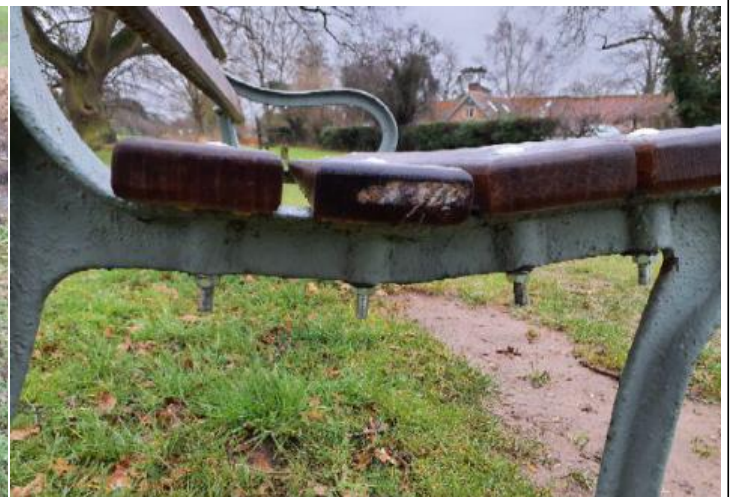
Item: Ancillary Items - Bench
Manufacturer: Not Identified

Finding: There are projecting bolt thread(s) present

Action: Remove excess thread length and deburr or provide cap

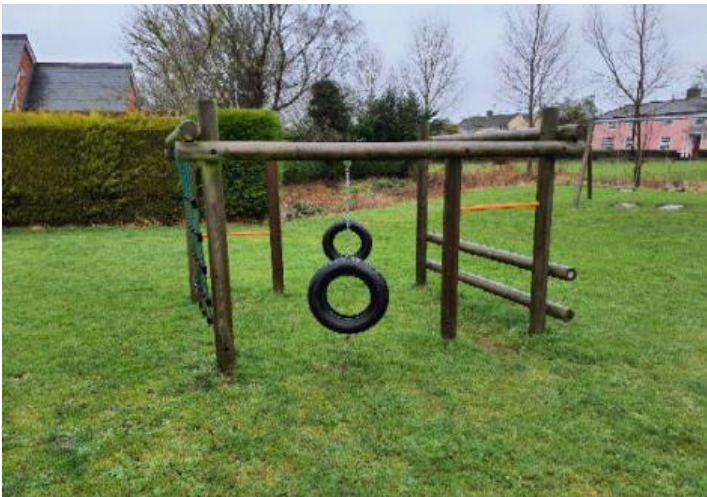
Item: Activity Equipment - Climbing Frame
Manufacturer: Playdale Playgrounds Ltd

Finding: The timber has a number of splits/shakes or air cracks and this may affect the stability or allow water ingress which will accelerate the rotting process

Action: Monitor to ensure the splits do not cross through fixing points of the structure and/or cause any instability

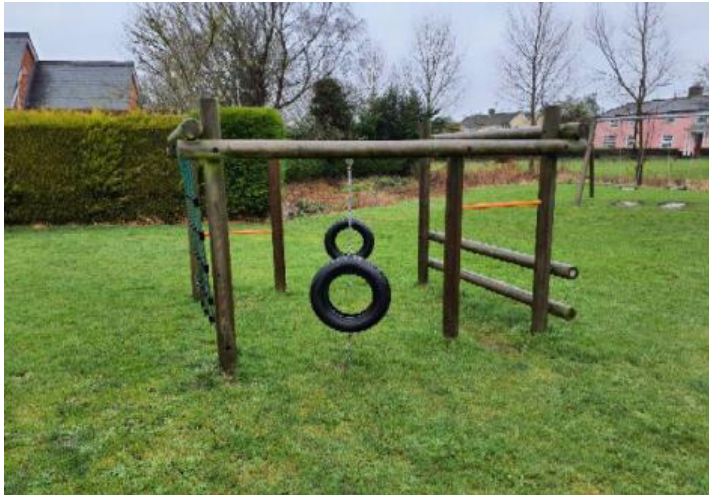
Item: Activity Equipment - Climbing Frame
Manufacturer: Playdale Playgrounds Ltd

Finding: There is some evidence of rot in the timber

Action: Monitor for any further deterioration and replace as required

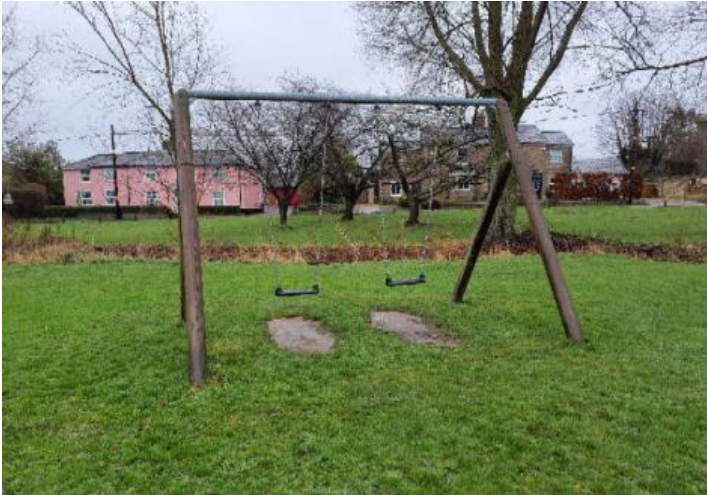
Item: Swings - 1 Bay 2 Seat (Flat)
Manufacturer: Playdale Playgrounds Ltd

Finding: There are areas or parts of the timber on the structure that have rotted

Action: Replace all affected timbers

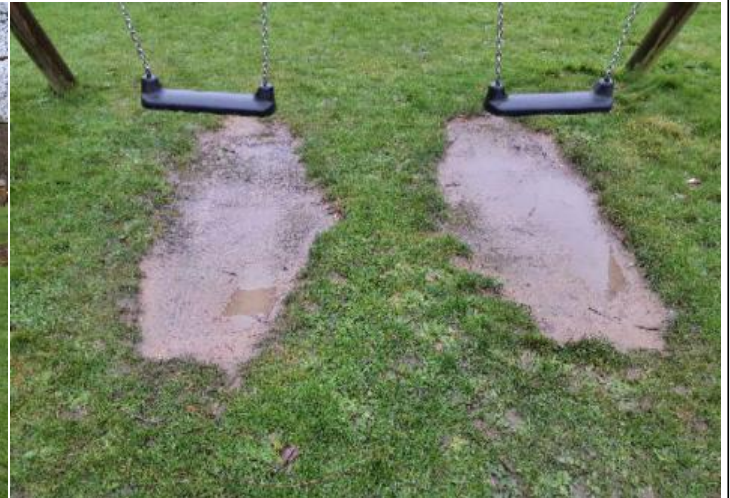
Item: Swings - 1 Bay 2 Seat (Flat)
Manufacturer: Playdale Playgrounds Ltd

Finding: The grass mats are silted up and the soil is compacted; this may have an effect on the impact absorbing properties of the surface. Consideration should be given to HIC testing the surface to verify impact attenuating properties (<https://playinspections.co.uk/inspection-services/safety-surface-testing/>)

Action: Contact our office for a quotation for this service

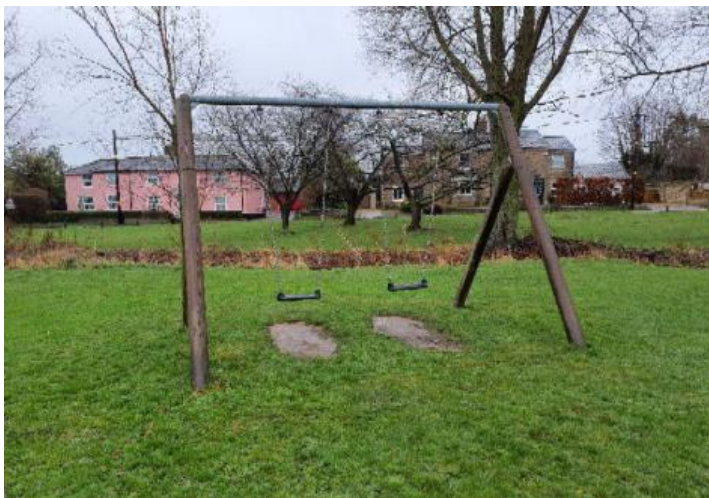
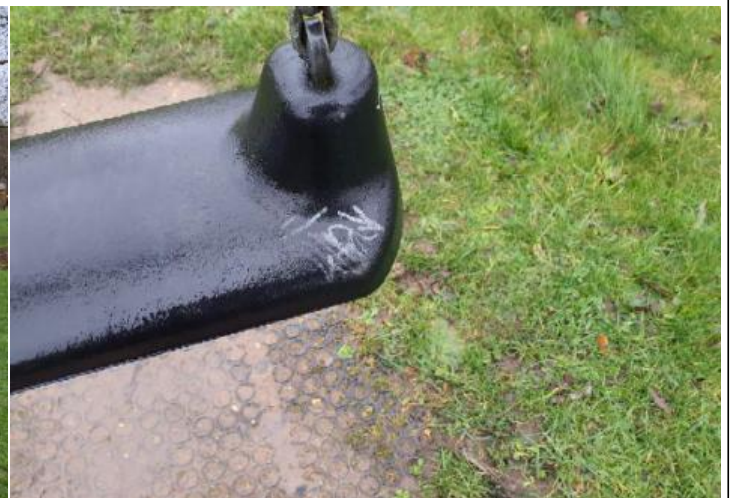
Item: Swings - 1 Bay 2 Seat (Flat)
Manufacturer: Playdale Playgrounds Ltd

Finding: There is some graffiti present

Action: Remove the graffiti

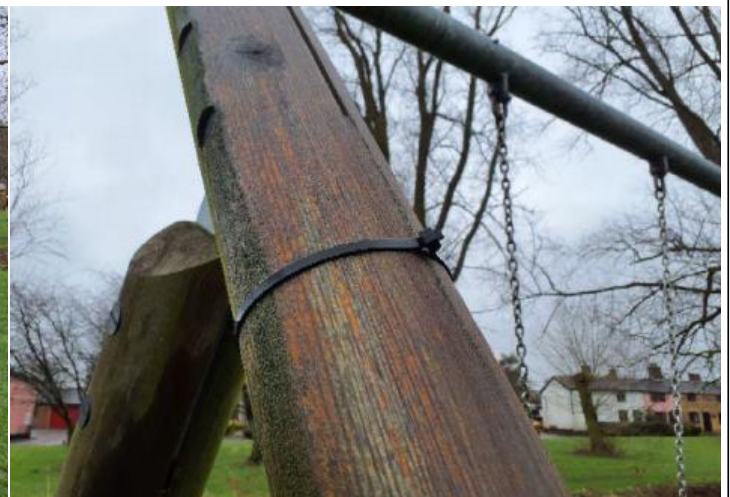
Item: Swings - 1 Bay 2 Seat (Flat)
Manufacturer: Playdale Playgrounds Ltd

Finding: There are redundant cable ties attached to the equipment

Action: Remove redundant cable ties

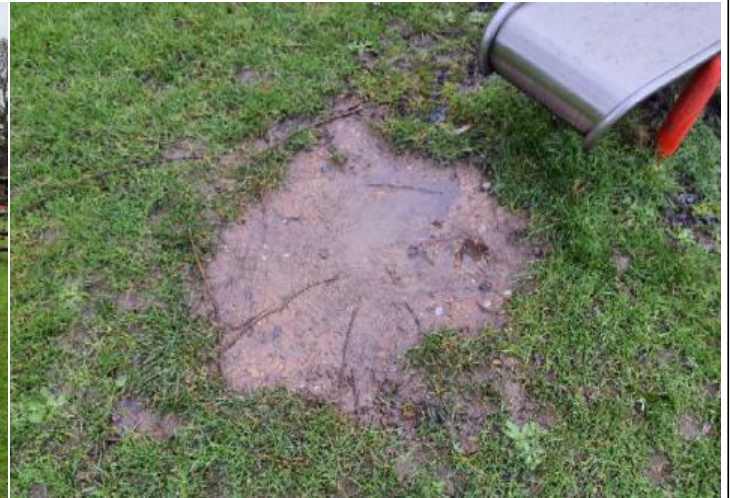
Item: Other - Free Standing Slide
Manufacturer: Not Identified

Finding: The grass mats are silted up and the soil is compacted; this may have an effect on the impact absorbing properties of the surface. Consideration should be given to HIC testing the surface to verify impact attenuating properties (<https://playinspections.co.uk/inspection-services/safety-surface-testing/>)

Action: Contact our office for a quotation for this service

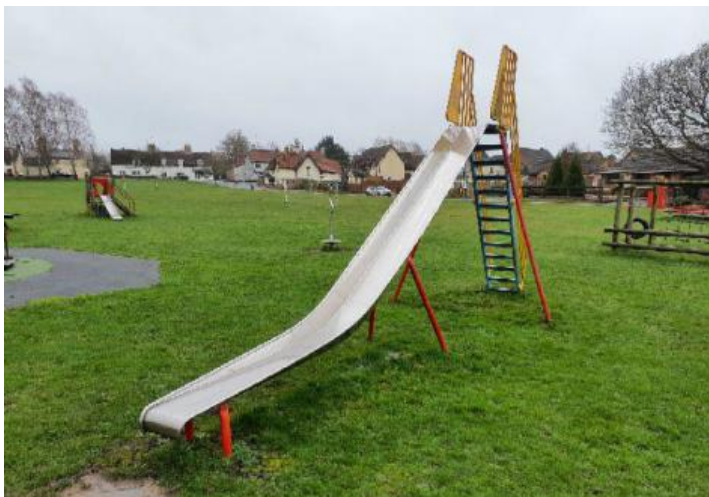
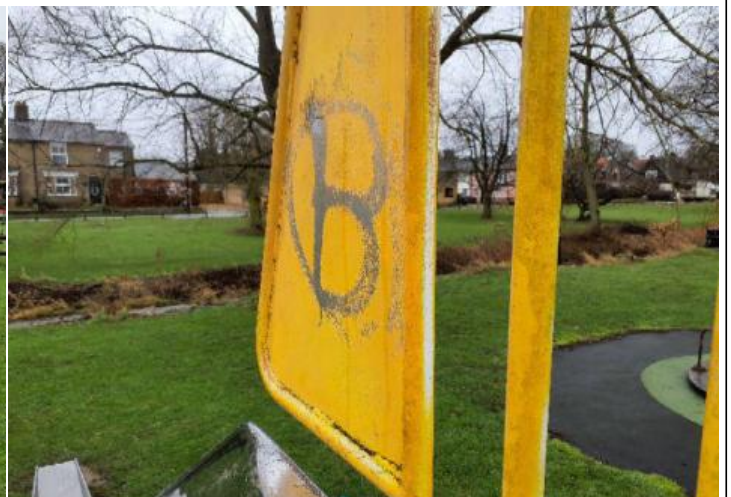
Item: Other - Free Standing Slide
Manufacturer: Not Identified

Finding: There is some graffiti present

Action: Remove the graffiti

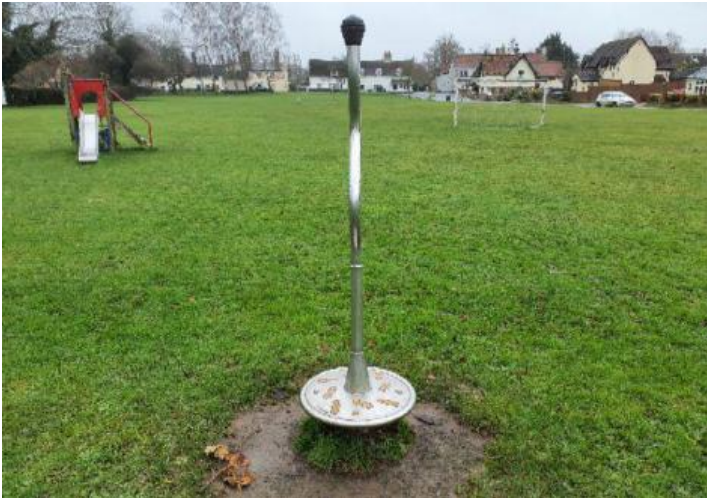
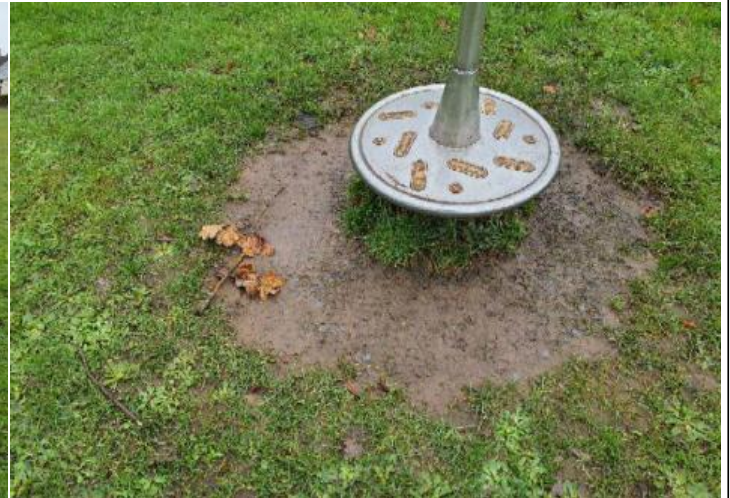
Item: Rotor Play - Spinning Pole
Manufacturer: Playdale Playgrounds Ltd

Finding: The grass mats are silted up and the soil is compacted; this may have an effect on the impact absorbing properties of the surface. Consideration should be given to HIC testing the surface to verify impact attenuating properties (<https://playinspections.co.uk/inspection-services/safety-surface-testing/>)

Action: Contact our office for a quotation for this service

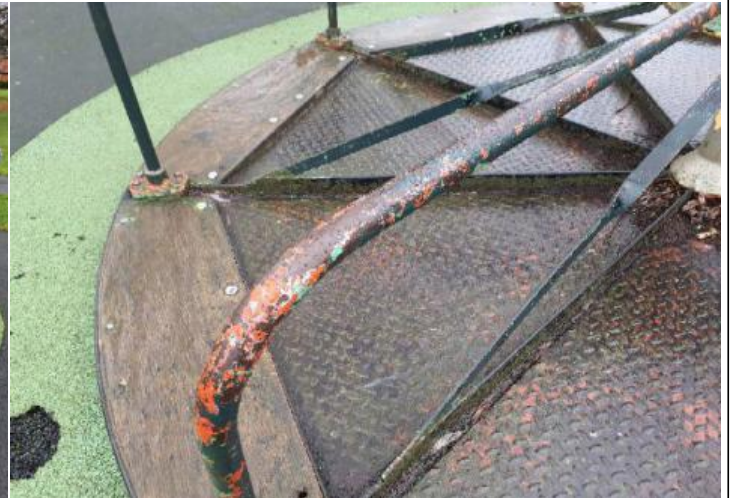
Item: Rotor Play - Roundabout
Manufacturer: Wicksteed Playgrounds

Finding: The paint is flaking off the metalwork

Action: Rub down and re-paint

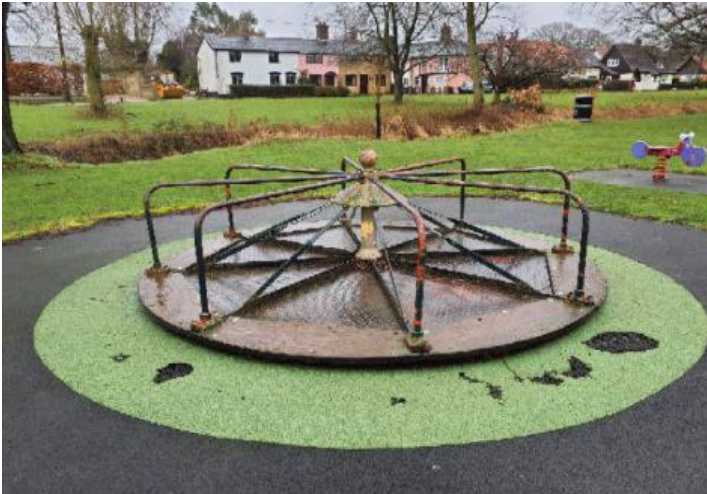
Item: Rotor Play - Roundabout
Manufacturer: Wicksteed Playgrounds

Finding: There is some evidence of rot in the timber

Action: Monitor for any further deterioration and replace as required

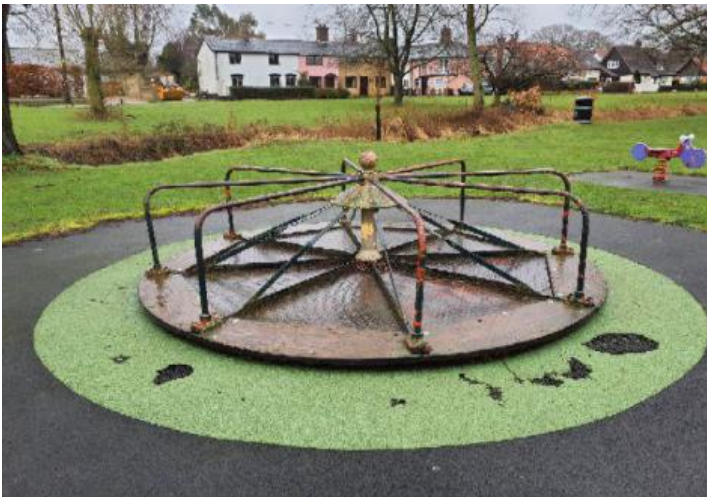
Item: Rotor Play - Roundabout
Manufacturer: Wicksteed Playgrounds

Finding: The bearing is showing signs of wear

Action: Monitor for any further deterioration and replace as required

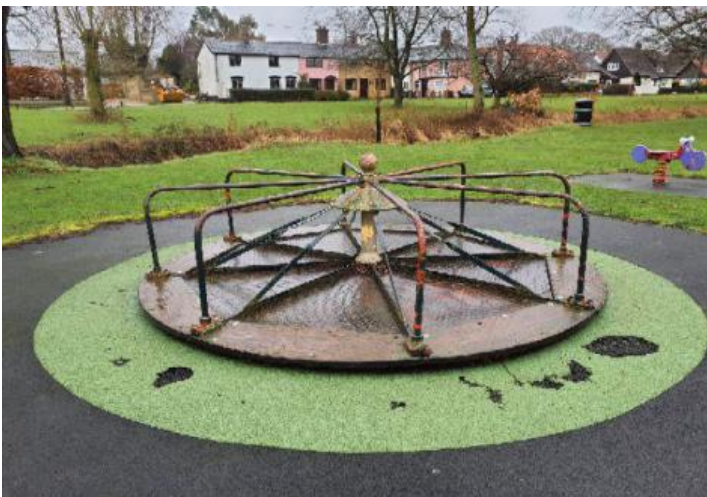
Item: Rotor Play - Roundabout
Manufacturer: Wicksteed Playgrounds

Finding: The surface is lifting at the edges and creating trip points

Action: Repair perimeter of surfacing to remove trip points

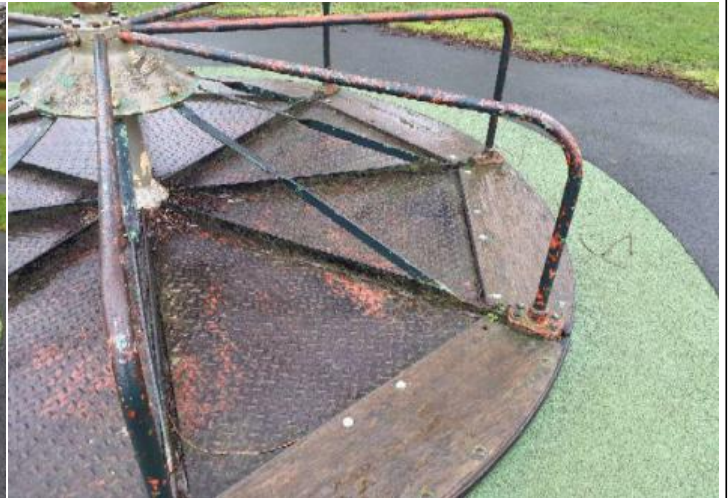
Item: Rotor Play - Roundabout
Manufacturer: Wicksteed Playgrounds

Finding: There is algae or moss on the surface of the equipment

Action: Clean and treat appropriately

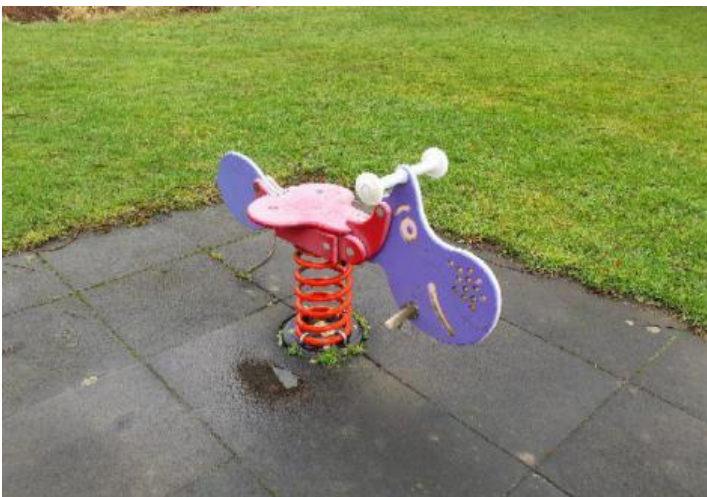
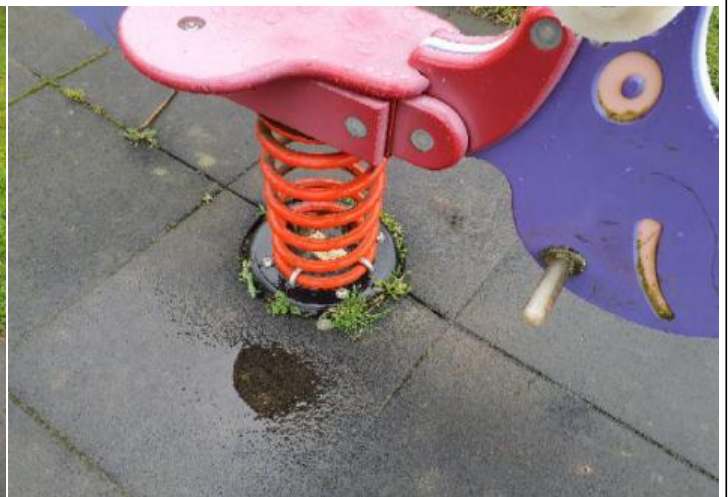
Item: Rocking Equipment - Spring Hippo
Manufacturer: S M P (Playgrounds Ltd)

Risk Level: L - Low Risk
Surface: Rubber Tiles

Finding: There is weed / vegetation growth on, between, or around the edges of the surfacing

Action: Remove weed / vegetation growth

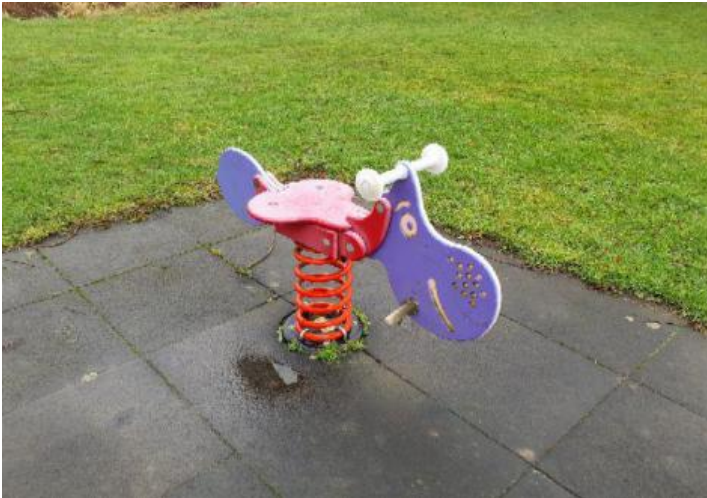
Item: Rocking Equipment - Spring Hippo
Manufacturer: S M P (Playgrounds Ltd)

Risk Level: V - Very Low Risk
Surface: Rubber Tiles

Finding: The timber edge forms a hard object within the impact area of the equipment in contravention of the requirements of BS EN 1176 Part 1

Action: Monitor - No remedial work recommended

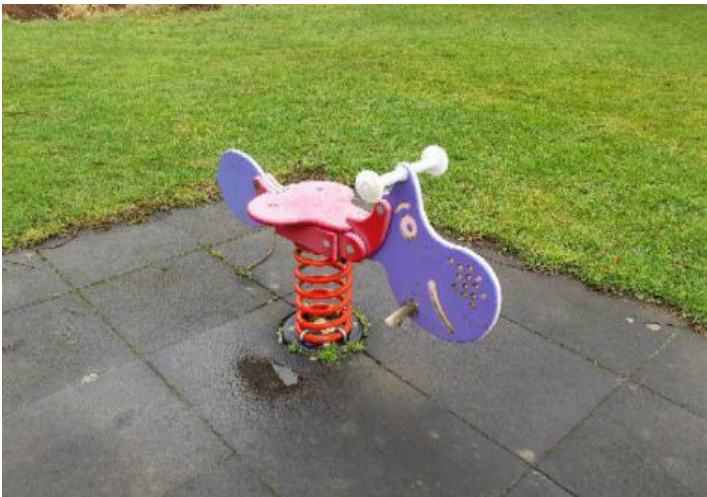
Item: Rocking Equipment - Spring Hippo
Manufacturer: S M P (Playgrounds Ltd)

Risk Level: V - Very Low Risk
Surface: Rubber Tiles

Finding: There is/are bolt cap covers missing or damaged on the item

Action: Replace missing or damaged bolt cap covers

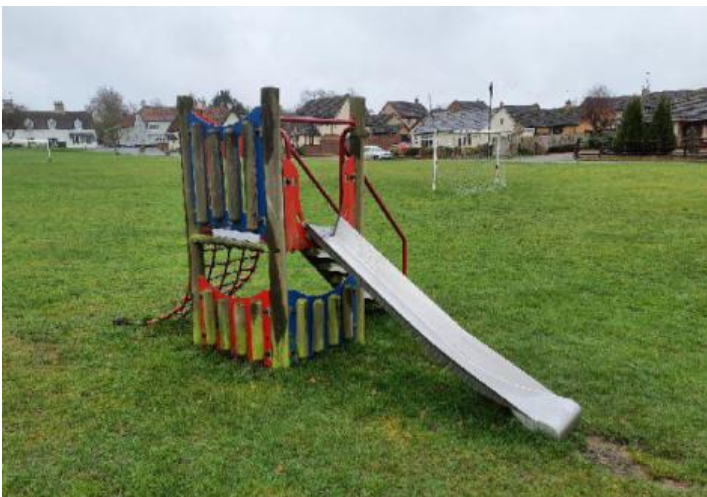
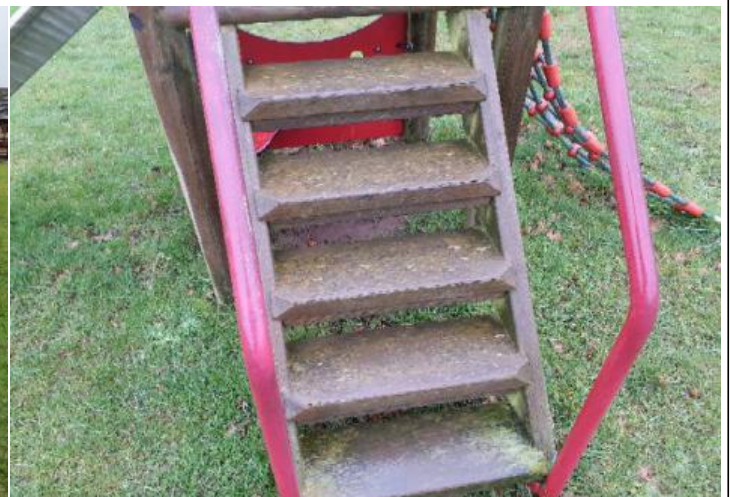
Item: Activity Equipment - Multi Play (Toddler)
Manufacturer: Playdale Playgrounds Ltd

Risk Level: L - Low Risk
Surface: Grass Matrix Tiles

Finding: There is algae or moss on the surface of the equipment

Action: Clean and treat appropriately

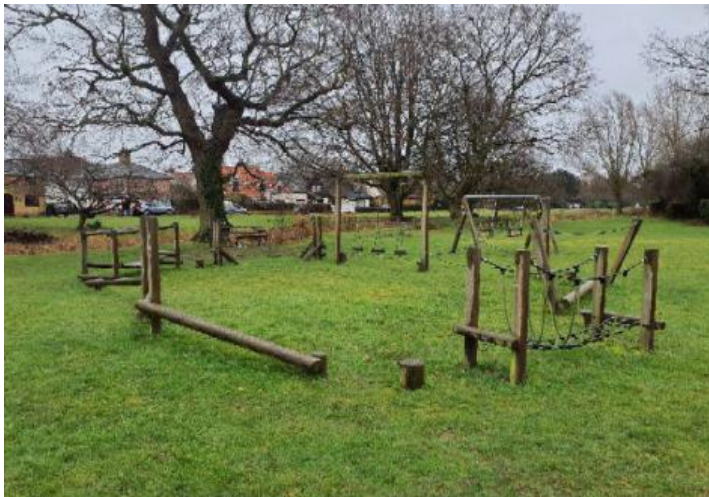
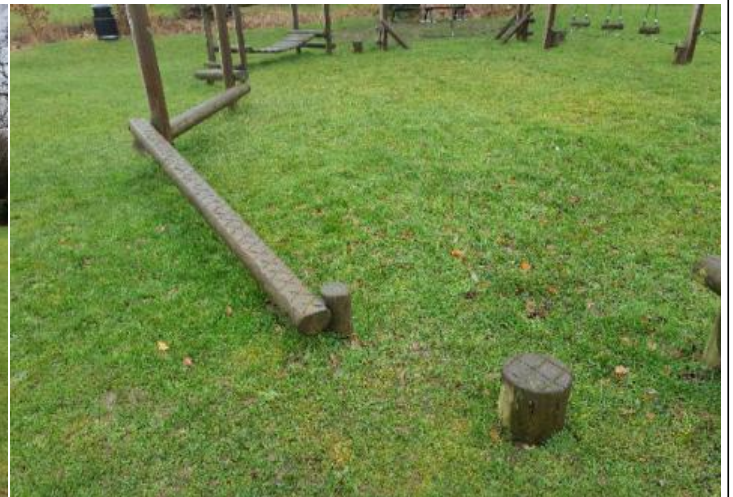
Item: Activity Equipment - Activity Trail
Manufacturer: Playdale Playgrounds Ltd

Risk Level: L - Low Risk
Surface: Grass Matrix Tiles

Finding: There is algae or moss on the surface of the equipment
Action: Clean and treat appropriately

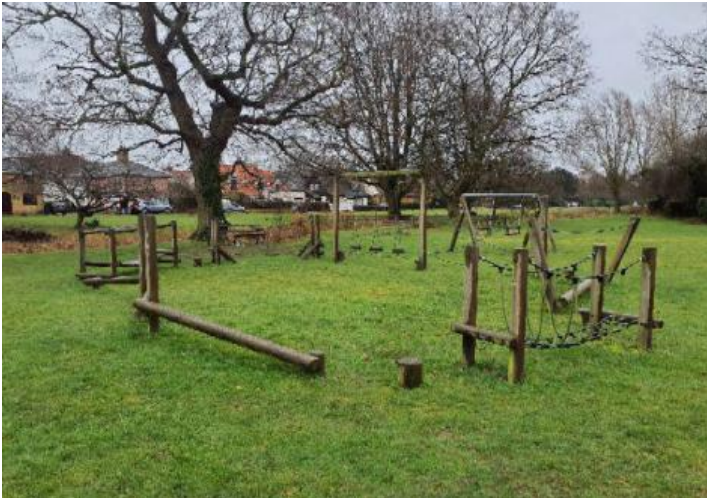
Item: Activity Equipment - Activity Trail
Manufacturer: Playdale Playgrounds Ltd

Risk Level: L - Low Risk
Surface: Grass Matrix Tiles

Finding: There is some strimmer / machinery damage apparent on the posts, this can penetrate the preservative applied to the timber and accelerate the rotting process

Action: Monitor for any deterioration (rot) and replace as required

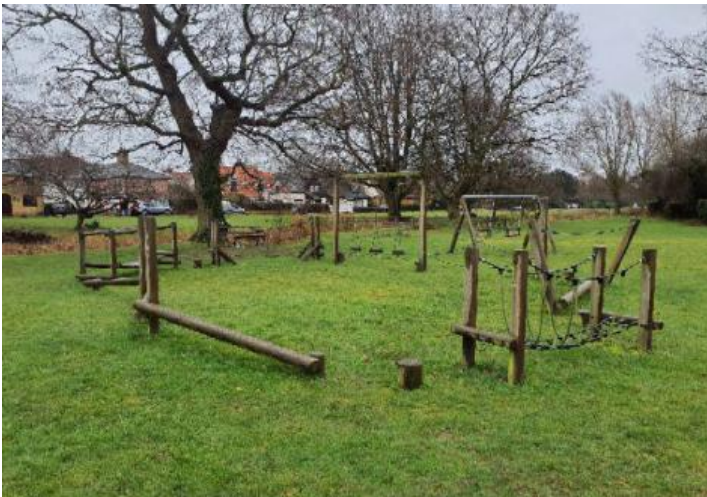
Item: Activity Equipment - Activity Trail
Manufacturer: Playdale Playgrounds Ltd

Risk Level: L - Low Risk
Surface: Grass Matrix Tiles

Finding: The ropes/nets are worn/damaged in places

Action: Monitor for any further deterioration and repair or replace as required

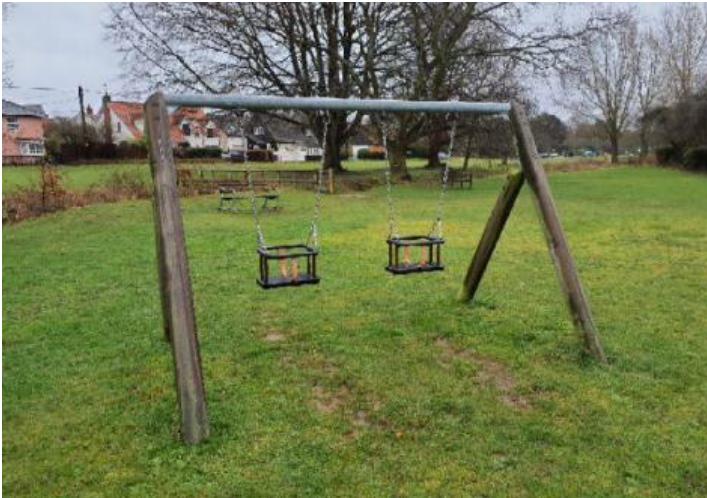
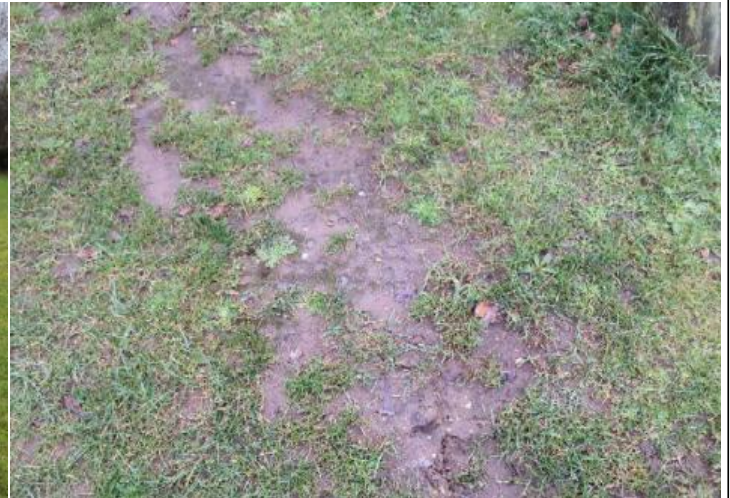
Item: Swings - 1 Bay 2 Seat (Cradle)
Manufacturer: Playdale Playgrounds Ltd

Risk Level: L - Low Risk
Surface: Grass Matrix Tiles

Finding: The grass mats are silted up and the soil is compacted; this may have an effect on the impact absorbing properties of the surface. Consideration should be given to HIC testing the surface to verify impact attenuating properties (<https://playinspections.co.uk/inspection-services/safety-surface-testing/>)

Action: Contact our office for a quotation for this service

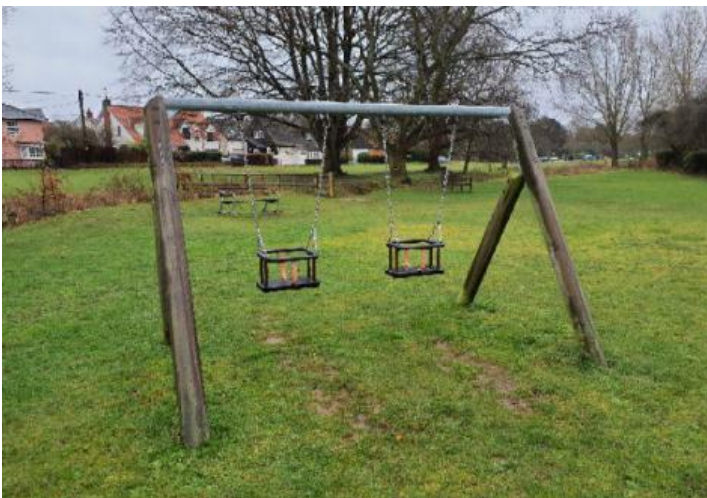
Item: Swings - 1 Bay 2 Seat (Cradle)
Manufacturer: Playdale Playgrounds Ltd

Risk Level: L - Low Risk
Surface: Grass Matrix Tiles

Finding: The seat has minor damage or wear

Action: Monitor for any further deterioration and replace as required

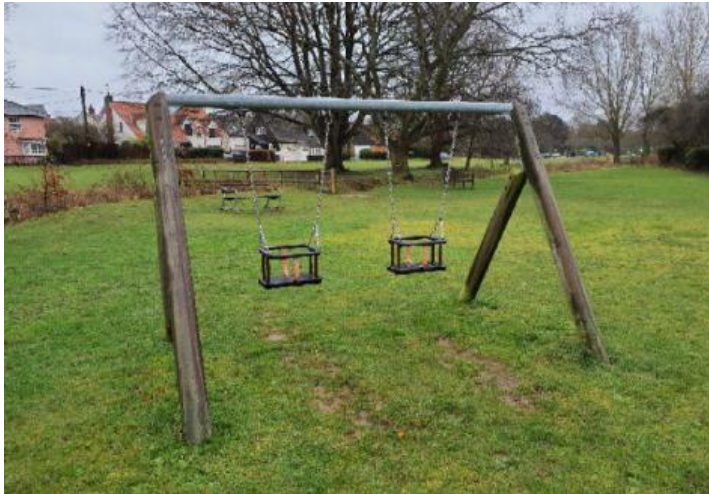
Item: Swings - 1 Bay 2 Seat (Cradle)
Manufacturer: Playdale Playgrounds Ltd

Risk Level: L - Low Risk
Surface: Grass Matrix Tiles

Finding: There is some notable evidence of chain wear

Action: Monitor for any further deterioration and replace when 40% worn

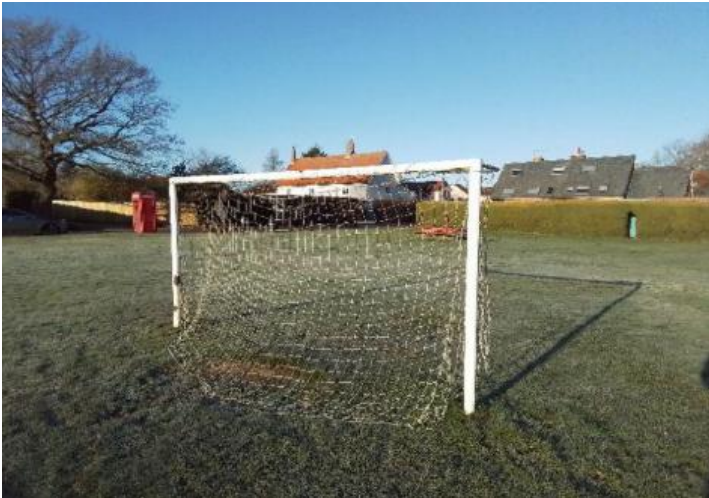
Item: Multi Use Games Area - 5 a side Goals
Manufacturer: Not Identified

Finding: NB: We have undertaken a maintenance inspection only of the football goal(s); full load testing falls outside the scope of our inspection.

Action: Implement load testing as required

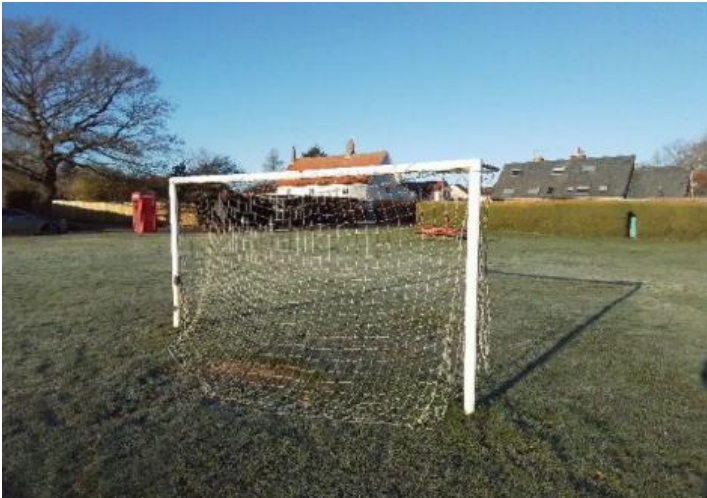
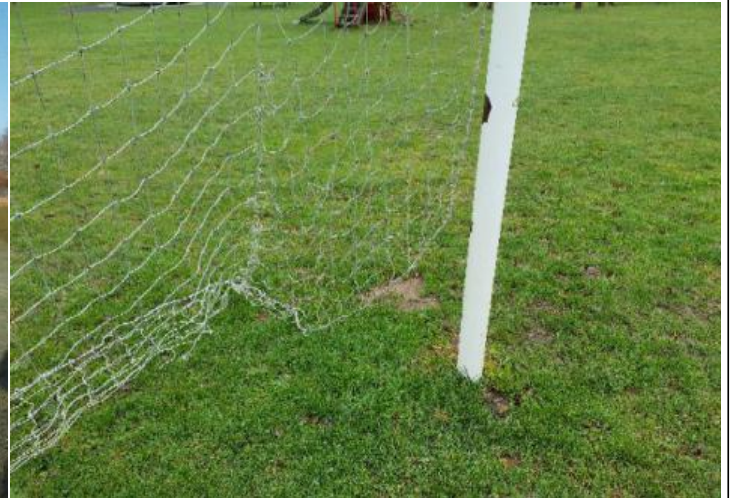
Item: Multi Use Games Area - 5 a side Goals
Manufacturer: Not Identified

Risk Level: L - Low Risk
Surface: Grass

Finding: The net is unsecured

Action: Secure net

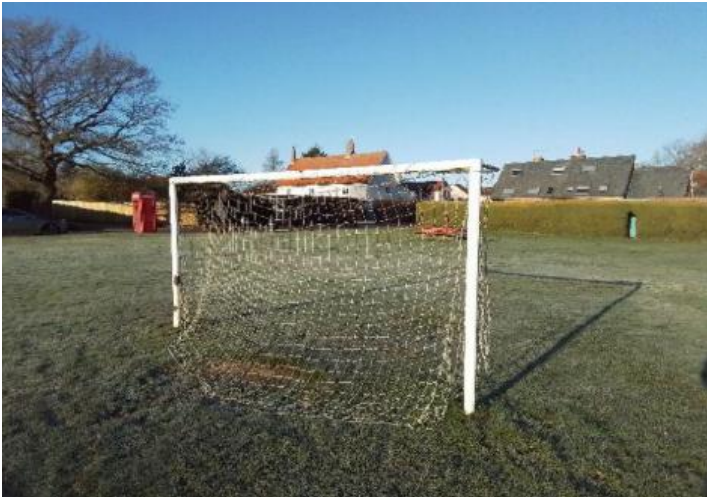
Item: Multi Use Games Area - 5 a side Goals
Manufacturer: Not Identified

Risk Level: L - Low Risk
Surface: Grass

Finding: There is or are fixings missing on the item

Action: Replace all missing fixings

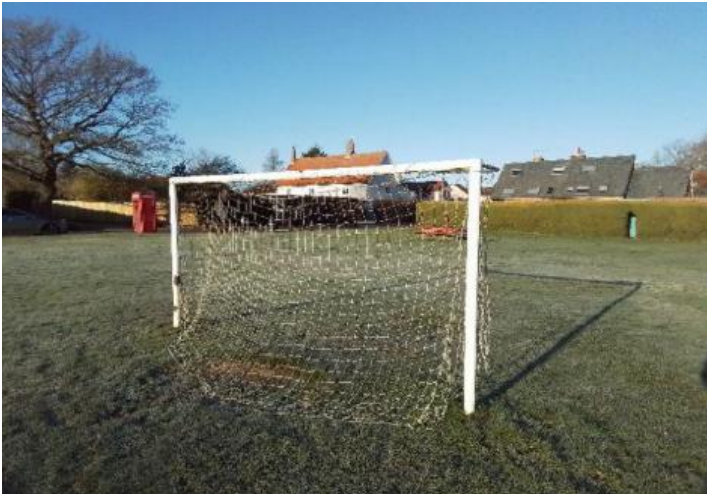
Item: Multi Use Games Area - 5 a side Goals
Manufacturer: Not Identified

Risk Level: L - Low Risk
Surface: Grass

Finding: The item is slightly loose in its foundations

Action: Monitor for any further deterioration and repair as required

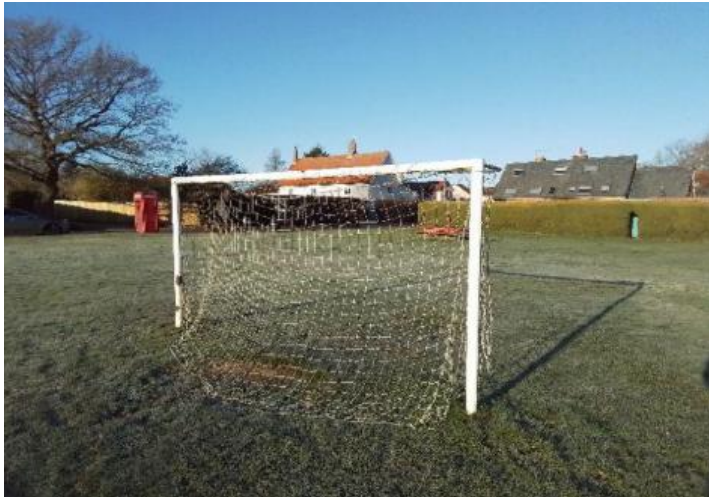
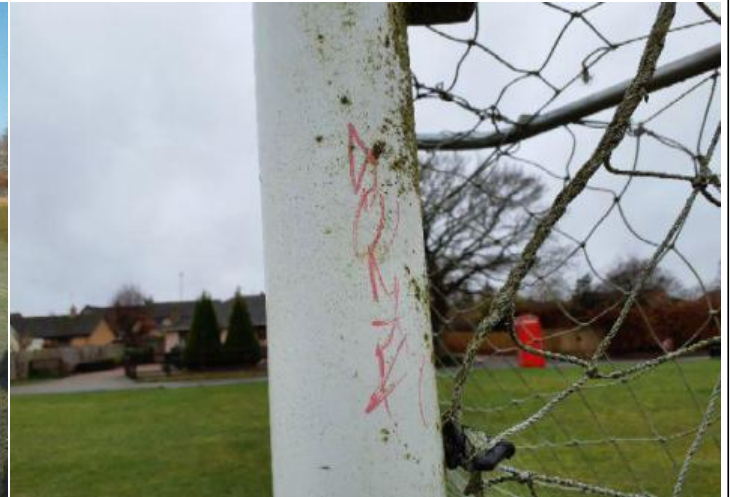
Item: Multi Use Games Area - 5 a side Goals
Manufacturer: Not Identified

Finding: There is some graffiti present

Action: Remove the graffiti
